## Damaged Cooling Tower Support Base At Northern California Hospital Repaired & Protected With DuraQuartz & ENESEAL

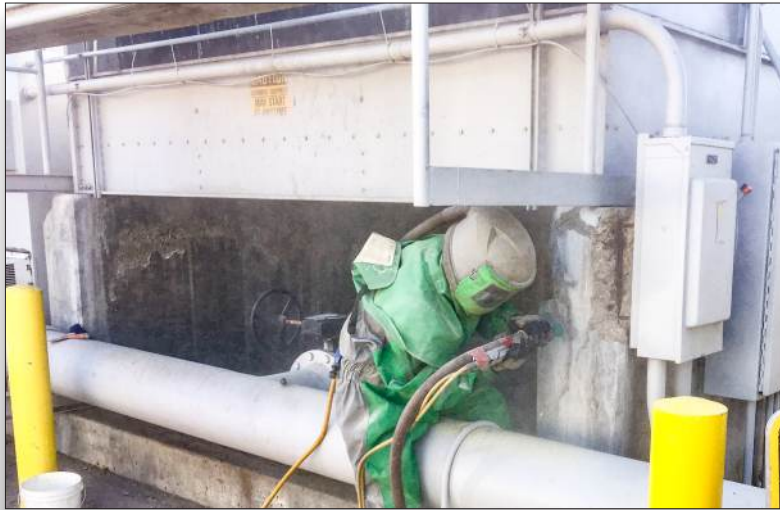
A northern California hospital's rooftop cooling tower concrete support base was badly damaged. This was from years of service in atmospheric corrosion and occasional seismic activity. The hospital needed a fast and cost effective solution to repair the damaged concrete.

1. All loose concrete pieces were removed. The concrete was ground or grit blasted to provide an adequate surface profile. The exposed rebar was coated with ENESEAL CR before the concrete was primed.

2. DuraQuartz LW was applied to the vertical and overhead surfaces and a former was made to restore the original shape of the base. DuraQuartz was also used in all other non-vertical or overhead areas.

3. All the DuraQuartz was polished smooth and then coated with two coats of ENESEAL CR to encapsulate and protect the base from future exposure to the elements.
