## South Florida Art Museum Uses METALCLAD, CHEMCLAD & ENESEAL To Protect Critical Cooling Tower Support Beams & Piping

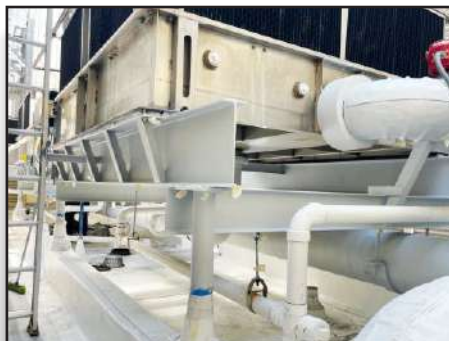
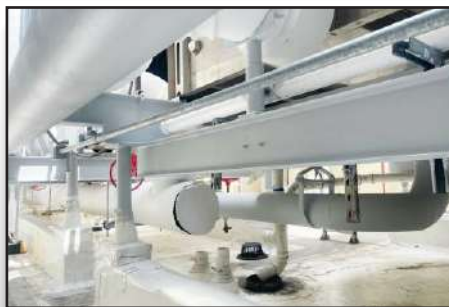
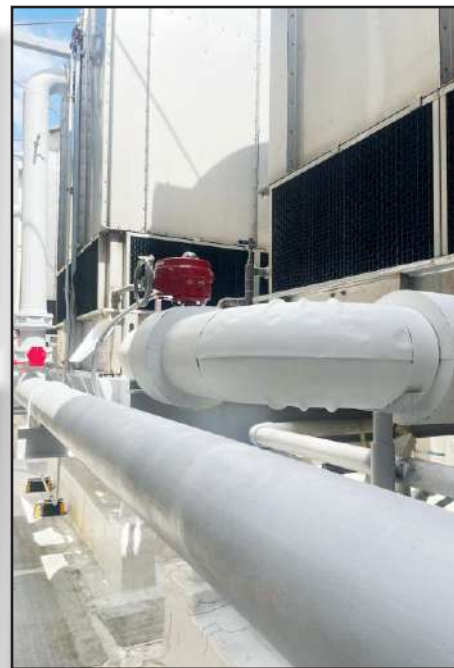
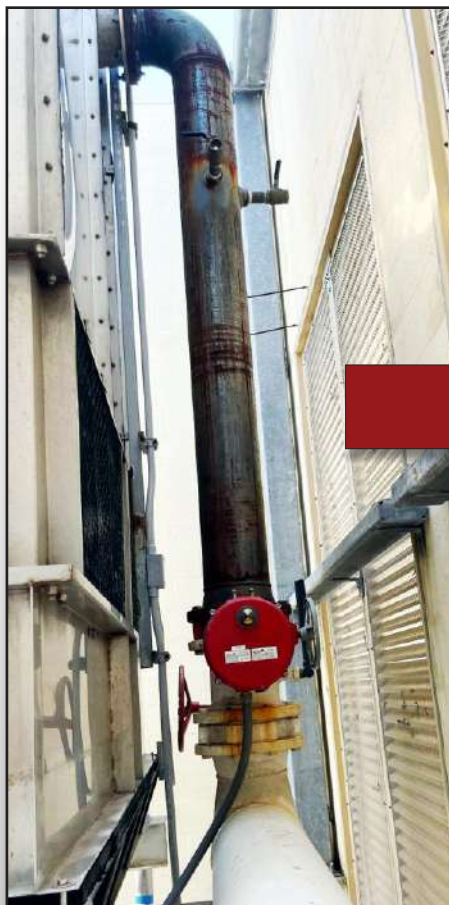
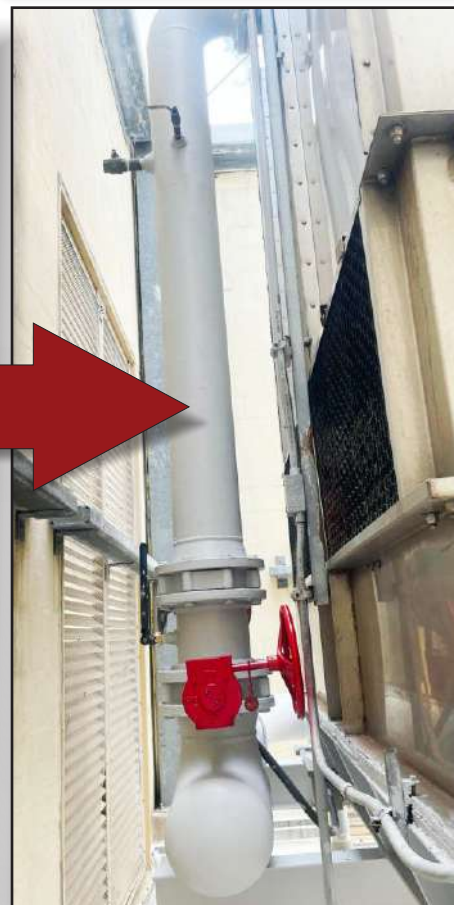
Two rooftop cooling towers at a South Florida art museum were experiencing severe corrosion and erosion of their support beams and piping.

ENECON's approach was comprehensive. All surface preparation was done manually with angle grinders, and *ENESEAL RC* was applied to heavily corroded areas to halt the rust. Any steel showing signs of erosion was repaired with *DurAlloy*, then sanded to meet the existing profile. To protect against chemically laden mist, two coats of *CHEMCLAD GP* were applied in at-risk areas.

Finally, the entire area was coated with two coats of *ENESEAL CR* (three coats in the most affected areas). Specific pipes were insulated with aluminum casings, and two final topcoats of *ENESEAL HR* were applied in those areas to provide heat refraction.
