French Petrochemical Plant's Heat Exchanger End Caps Are Repaired & Protected With CeramAlloy CP+AC & CL+AC

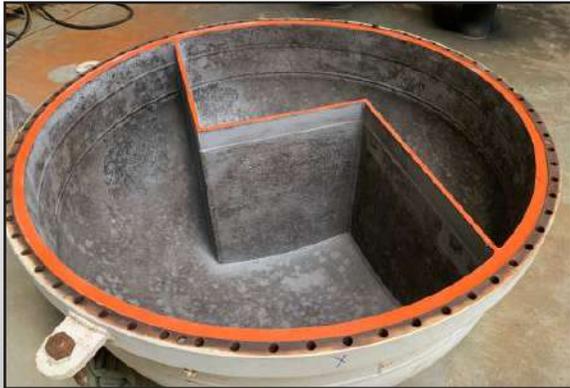
While being dismantled for regular maintenance it was observed that the internal surfaces of these heat exchanger end caps were suffering from severe erosion due to continuous, pressurized hot water flow.

After, grit blasting, vacuuming and degreasing all surfaces, repairs to any damaged areas with

CeramAlloy CP+AC were made.

Two coats of CeramAlloy CL+AC (first gray, then blue) were then applied to each of the two end caps.

This application was completed in 24 hours, allowing the petrochemical plant's maintenance team to return these heat exchangers to service with very minimal down time.
