## After 14 years In Service, CeramAlloy Is In Perfect Condition At Steel Mill

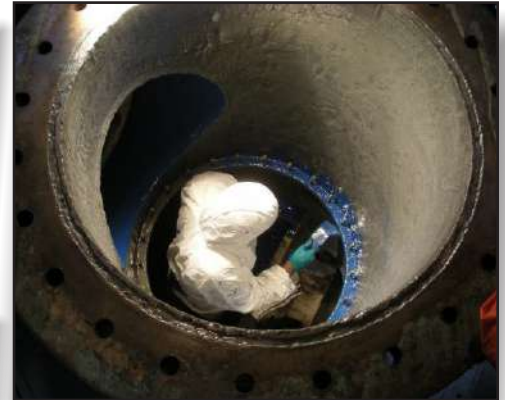
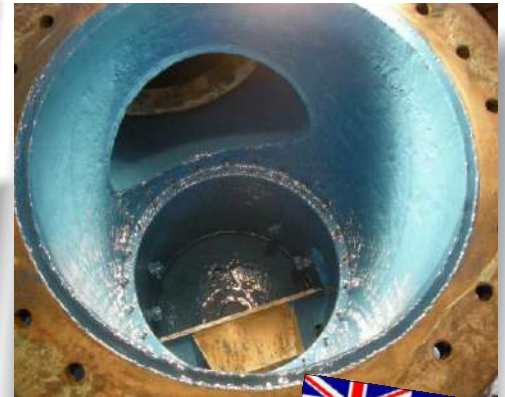
Located at a steel mill in Australia, this strainer had potentially come to the end of its working life due to extensive corrosion pitting. Over the years different epoxy materials were unsuccessfully used in an attempt to protect it from the aggressive recycled water.

To solve this problem, the plant maintenance team contacted the ENECON Distributor in Australia. It was agreed to rebuild the entire internal surfaces of the strainer with *CeramAlloy CP+AC* and then *CeramAlloy CL+AC*.

The first stage in surface preparation was to abrasive blast the strainer in order to remove all the failed coatings and corrosion. The steel was then washed down and left over night to enable impurities to leach out. After re-blasting, *CP+AC* (ceramic paste) was applied to fill the extensive corrosion

pitting. While the *CP+AC* was still tacky, a layer of *CL+AC* (ceramic liquid) was applied to provide the highest degree of erosion and corrosion protection.

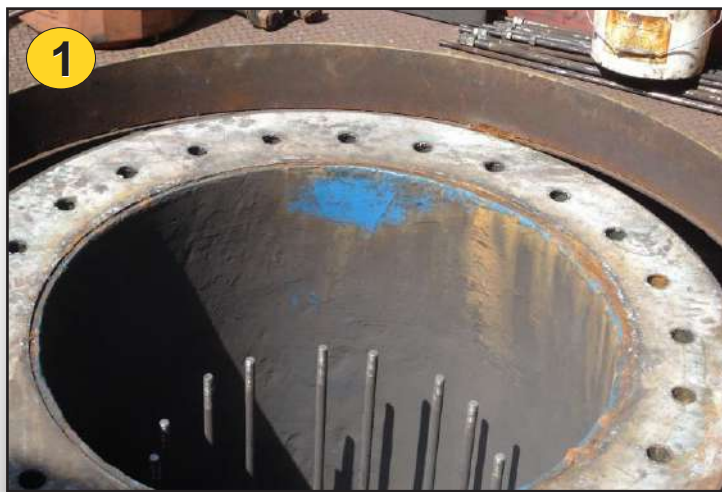
**After 5 years**

Approximately 5 years later, the strainer was inspected to monitor the condition of the repair. As shown in photo 1, below, the blue *CL+AC* was showing no signs of deterioration and was performing perfectly under the dirt residue.

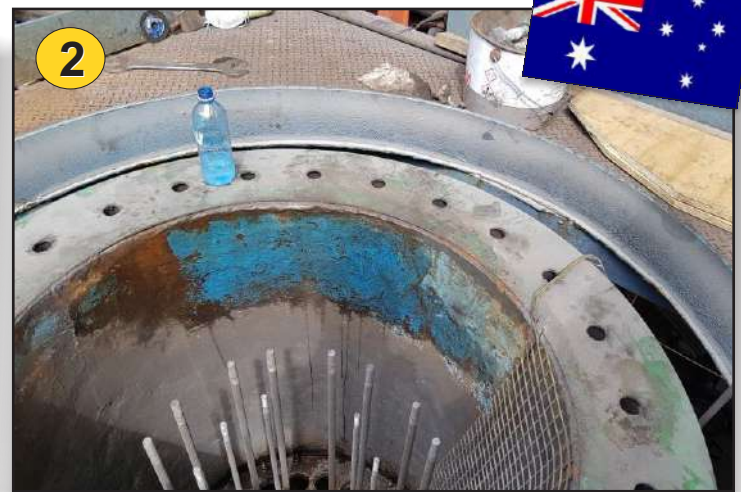
**After 14 years**

Nearly 14 years after the initial project, the strainer was inspected again.

Once again the *CeramAlloy* was still in original condition under the recycled water residue shown in photo 2. Even maintaining its original gloss after being wiped down with a small amount of bottled water.
