Mid-Western US Ethanol Plant Cooling Tower Pump Cavitation Eliminated Using CeramAlloy & DuraTough

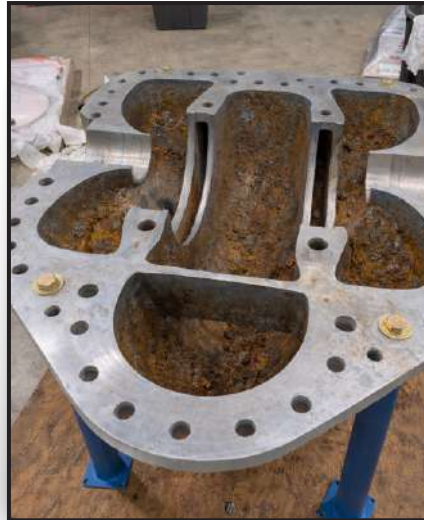
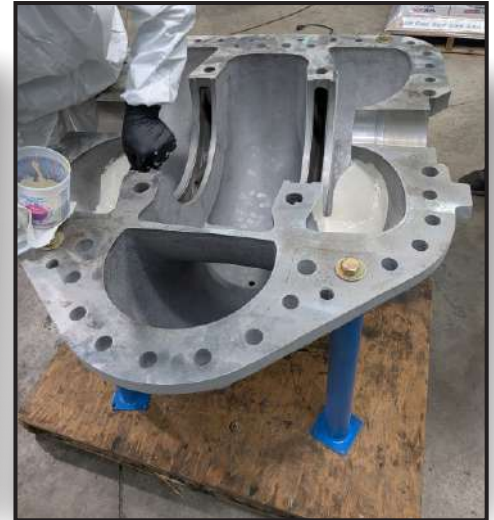
This cooling tower pump from an ethanol plant was suffering from severe corrosion and cavitation damage at the intake, ultimately rendering the pump beyond repair. The local ENECON Engineering Specialist recommended a solution that many would not have considered.

The pump's internal surfaces were properly prepared by abrasive blasting to a white metal finish with a 5–7 mil profile, then protected with two coats of CeramAlloy CL+AC, providing a durable,

corrosion-resistant barrier.

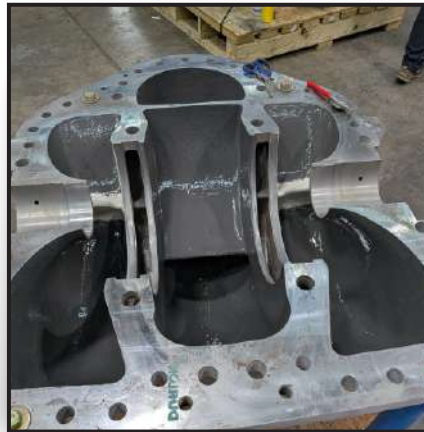
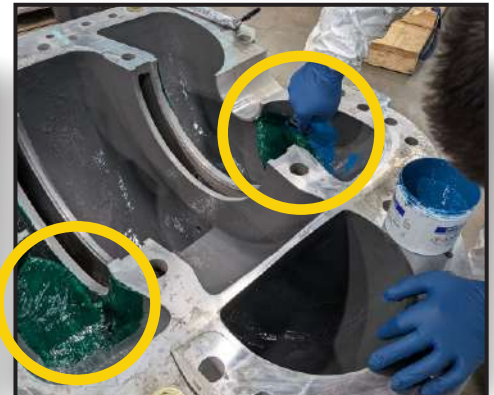
DuraTough DL applied to stop cavitation.

The areas most heavily impacted by cavitation were further reinforced with two coats of *DuraTough DL*, delivering exceptional resistance to aggressive erosion accelerated by cavitation. These areas were not overcoated with CeramAlloy CL+AC.

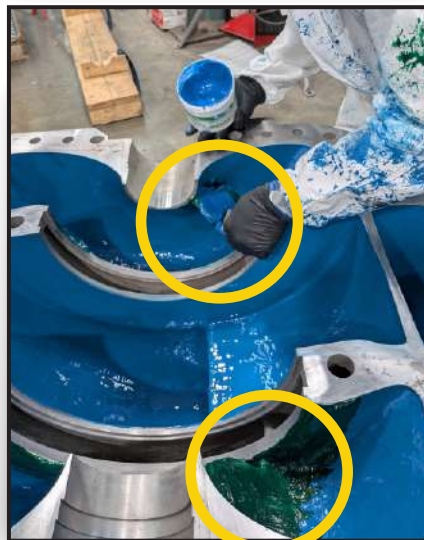
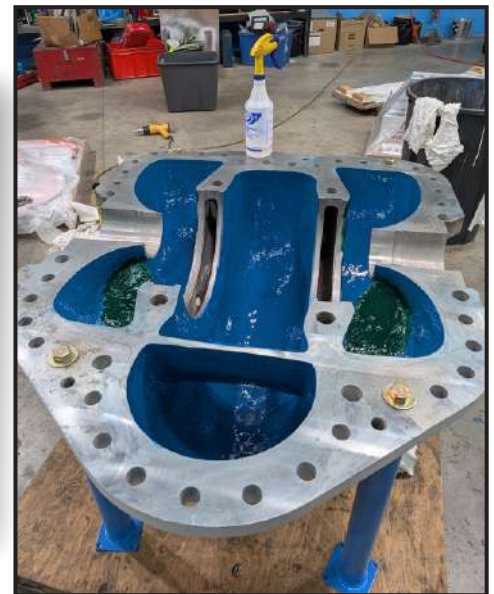
DuraTough DL not overcoated by CeramAlloy CL+AC.
