Large Pump Columns Restored & Protected With DurAlloy, CeramAlloy & CHEMCLAD

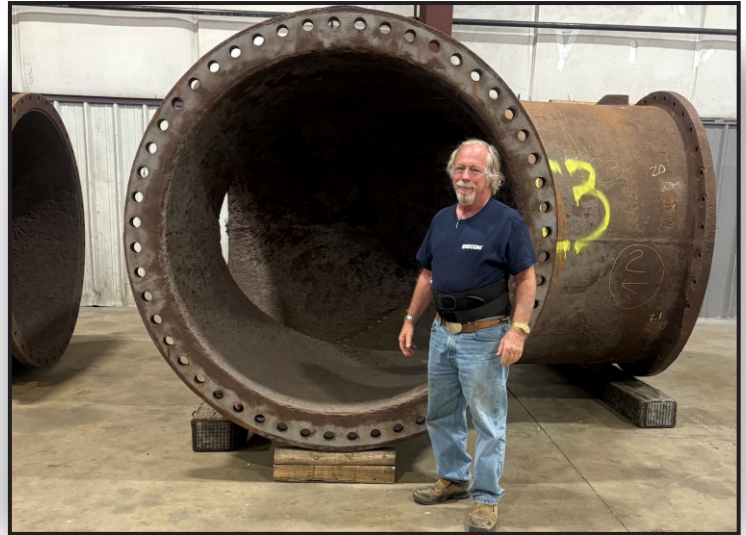
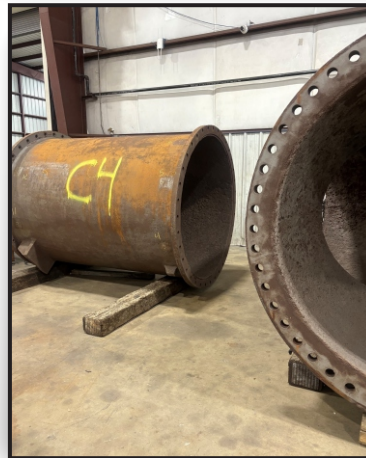
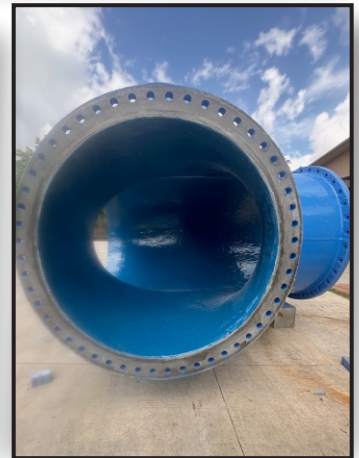
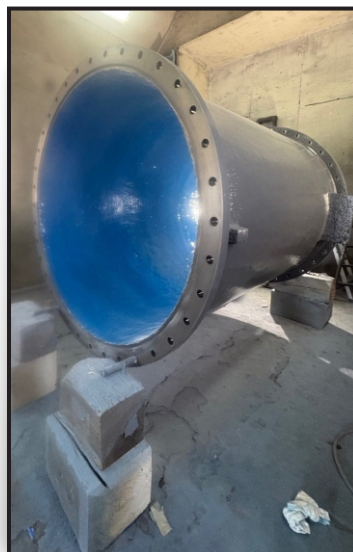
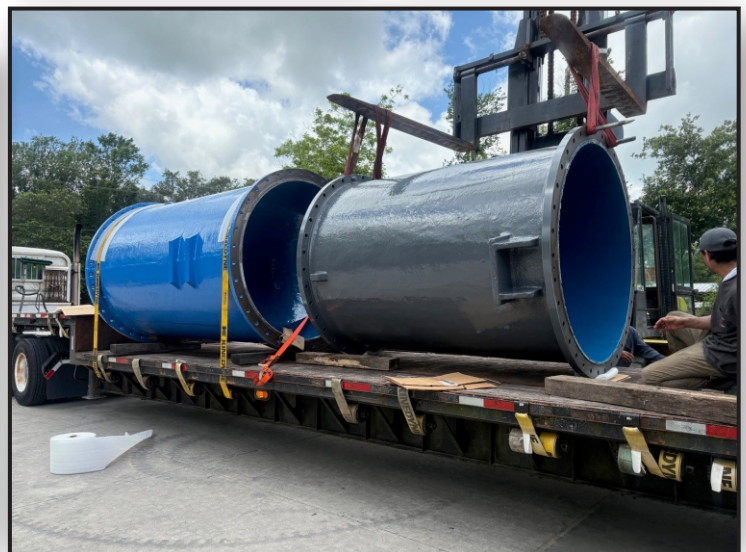
A leading industrial service contractor in Texas was selected to refurbish several large pump columns/casings for a major power generation facility. Years of service had left the columns with extensive corrosion and severe pitting on both the internal and external surfaces. The objective was to restore the damaged components and provide long-term corrosion protection rather than replace them.

Following abrasive blasting, the severely pitted areas were repaired and rebuilt with **METALCLAD DurAlloy**. Once the repairs were completed, two coats of **METALCLAD CeramAlloy CL+AC** were applied to the interior surfaces, providing exceptional long-term corrosion protection. The exterior surfaces received two coats of **CHEMCLAD GP**.
