Biotech Company Solves Chemical Problem in Their Research Lab with SuperBond and CHEMCLAD XC

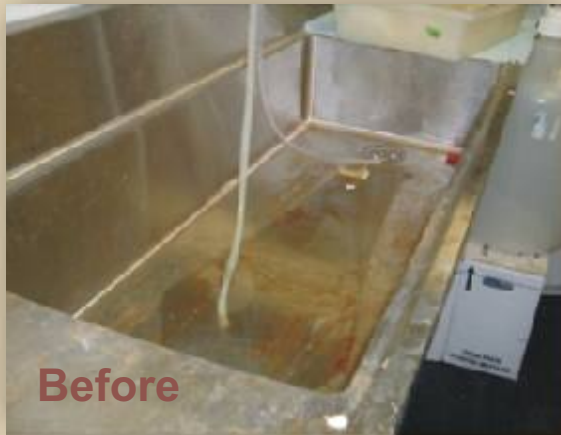
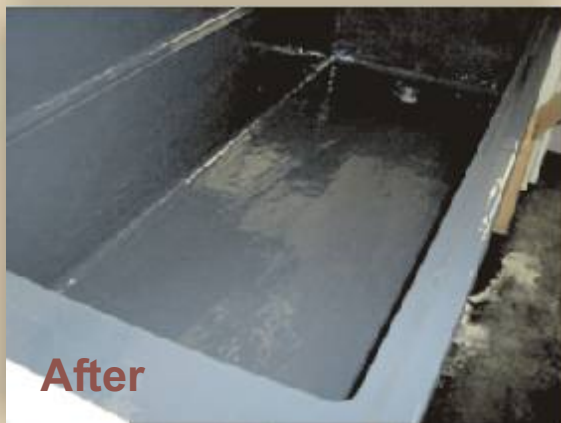
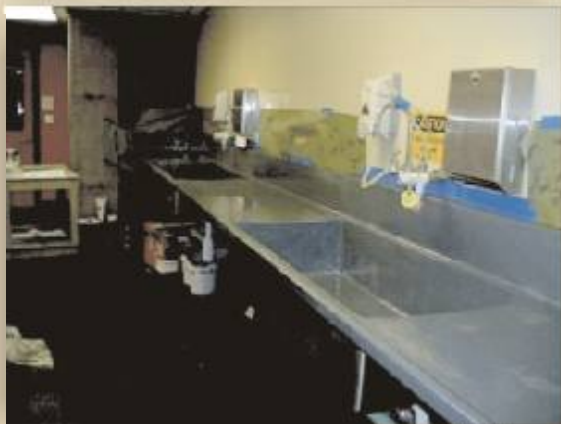
A prestigious biotech company, based in Seattle, WA, was experiencing a serious corrosion problem on their stainless steel sinks in one of their research laboratories. They needed a quick and environmentally friendly answer. Their SOS went out to the ENECON Northwest Engineering Team, who proposed a very cost effective repair solution.

Since grit blasting was out of the question in the lab, Allen Thomas, ENECON's District Sales Manager in Seattle, proposed a thorough cleaning of the

stainless steel surfaces and a final wipe with acetone. ENECLAD SuperBond was applied to all stainless steel surfaces and then two coats of CHEMCLAD XC were applied to seal any pinholes and protect the sink surfaces from future chemical attack.

The application was completed in just two days with minimal disruption to the research laboratory personnel.
