## Geothermal Power Plant Uses CHEMCLAD GP to Stop Corrosion on Waste Removal Trailers

Client: Geothermal power plant located in California.

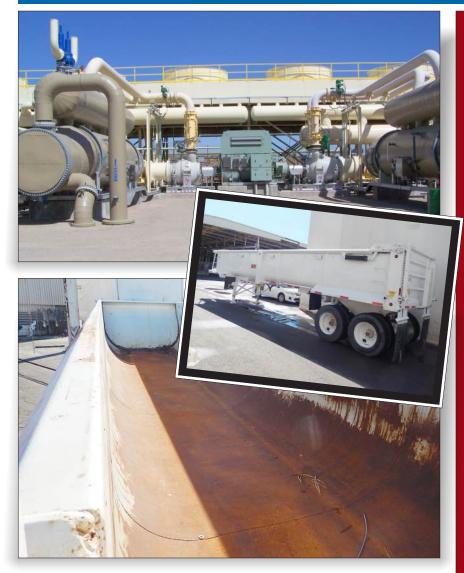
Problem: Corrosion to the steel beds of the trailers used to transport geothermal waste product (very salty brine mineral debris) to waste facilities.

Solution: Various conventional paints and liners had been used over the years and all of them had failed very quickly.

The trailer beds were grit blasted and two coats of CHEMCLAD GP were sprayed onto the 550 sq ft beds.
