University Science Center Solves Leaking Mechanical Room Floor Problems With ENECRETE & CHEMCLAD

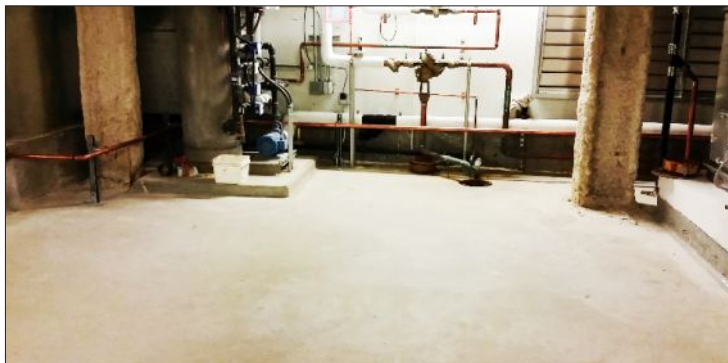
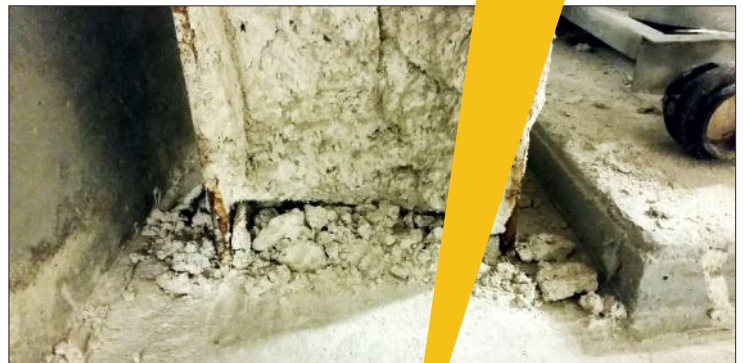
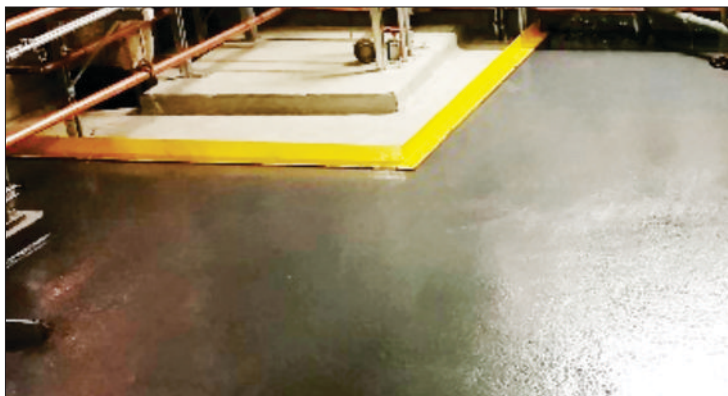
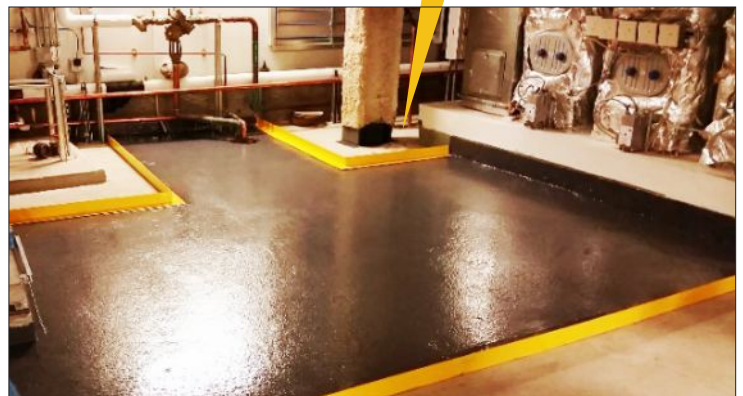
At this urban university science center building, a 7th floor mechanical room was experiencing flooding due to an insufficient drainage system. The flooding was leaking down to the floor below, causing damage to the offices on that floor. The structural I-beam bases were corroding and losing their fire retardant coating.

After the entire surface was cleaned and loose material was removed, angle iron was used to create a small containment area near the drain that was prone to flooding. It was first bolted then METALCLAD DurAlloy was used to create a water tight bond to the floor.

Two coats of CHEMCLAD SC were applied to the entire containment area and the base of the I-beams. CHEMCLAD SC in safety

yellow was also used on the angle iron to prevent tripping.
