## Thermoelectric Power Plant In Chile Protects Secondary Containment Areas With ENECRETE & CHEMCLAD

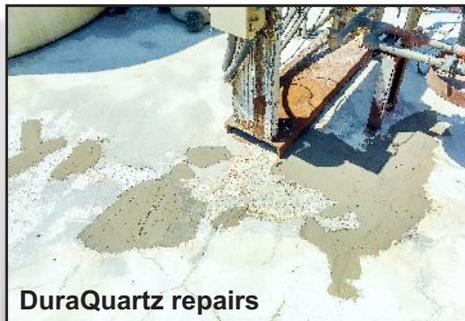
DuraQuartz repairs

The ENECON Chile team removed all contaminated concrete as well as old, failed coatings. Broken and cracked concrete areas were repaired and rebuilt with *ENECRETE DuraQuartz* and *ENECRETE DuraFill*.

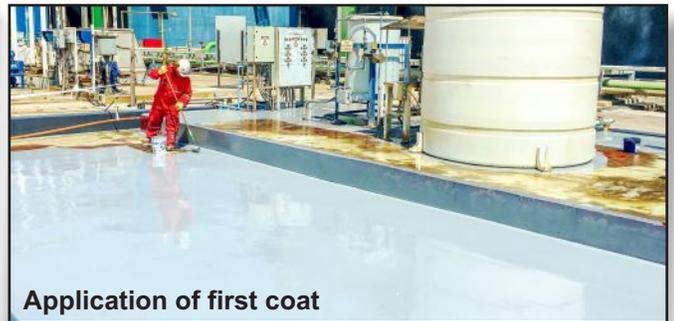
Application of first coat

The entire surface of the secondary containment areas were then coated with two coats of *CHEMCLAD XC* and *CHEMCLAD SC* (depending on the chemical exposure), providing superior chemical attack protection from these extreme conditions for years to come.

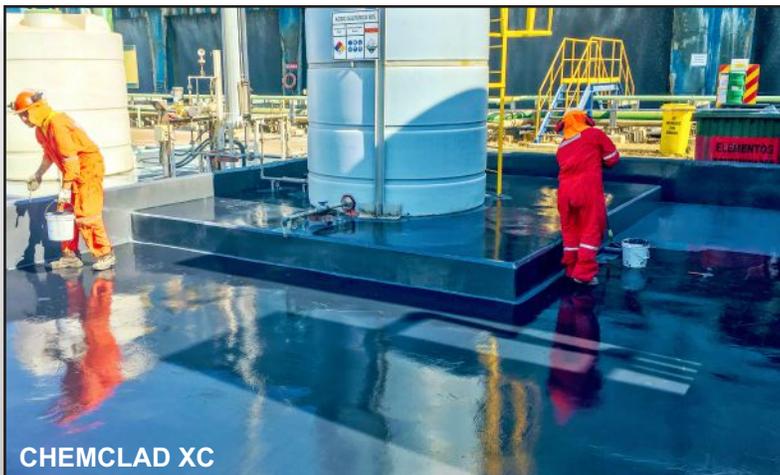
CHEMCLAD XC

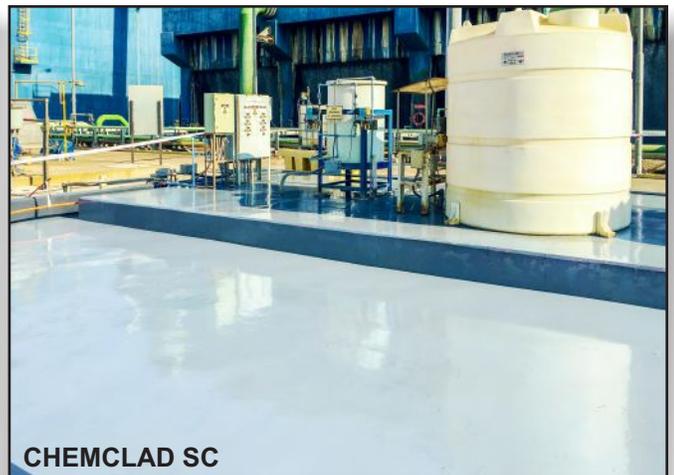
CHEMCLAD SC
