Leaking Hospital Kitchen Grease Trap Is Repaired With DurAlloy & Protected With CHEMCLAD

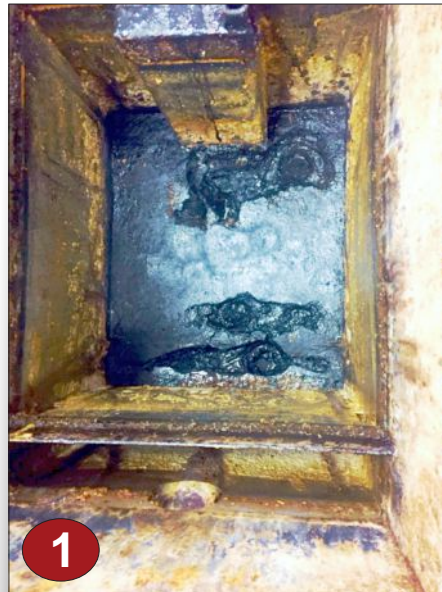
This particular grease trap (1) is a pit located underground at a Pennsylvania hospital kitchen. It was leaking into the ground, which was a concern for the hospital maintenance team. A full replacement of the grease trap would have been very expensive and caused major disruption to the hospital's busy kitchen for days.
