## ENECON® NEVS

## **Australian Steel Mill Submersible Pumps Protected With CHEMCLAD**

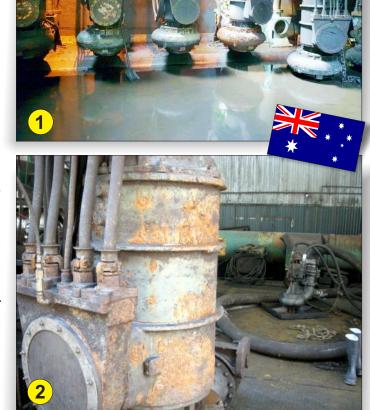
All the recycled water from the descaling process at a steel mill in Australia ends up in a large, underground pit. The submersible pumps inside the pit push the water back up through strainers so it can be pumped to other parts of the mill (Photo 1).
