## Honduran Textile Mill Salvages Floors with DuraFill, CHEMCLAD & ENECLAD

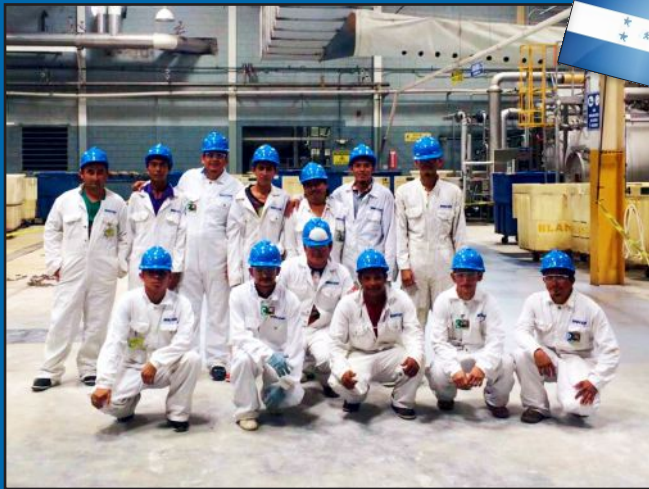
Over 14,500 sq. ft. of floors inside a major textile mill located in Honduras were damaged from chemicals used in the textile dyeing process and traffic from material handling trucks and lifts. The mill's engineers wanted a coating system that could offer years of protection as well as easy cleaning.

The floors were manually prepared with grinding tools to remove the old, failing epoxy coating then cleaned with a solvent. *ENECRETE DuraFill*, mixed with sand, was used to repair holes and any

imperfections of the concrete's surface. After these repairs were made a mixture of *DuraFill* and very fine sand was screed with a trowel to level the surface and prime for the top coat.

Two coats of *CHEMCLAD SC* were applied to the areas exposed to potential chemical spills with a light quartz sand broadcast and back-rolled onto the surface for slip resistant properties. In other less aggressive environments of the mill, *ENECLAD FPS* was applied along with *Safety Yellow* for required safety striping.

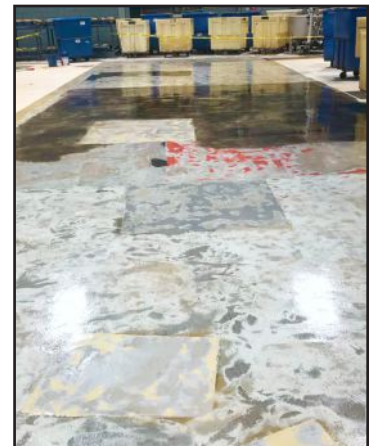
Repairs made with *DuraFill*
