## Florida Municipality Repairs & Protects Vacuum Truck Tank With METALCLAD & CHEMCLAD

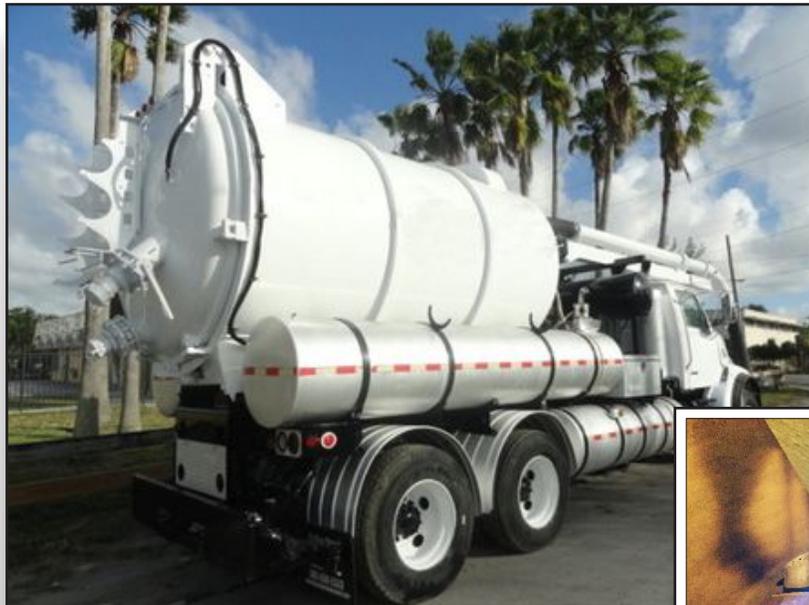
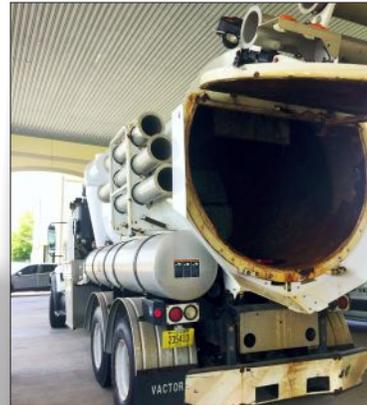
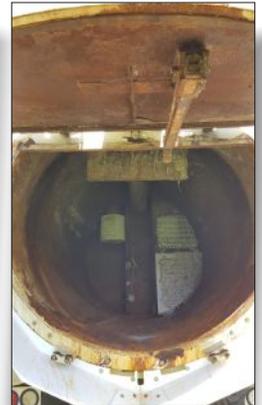
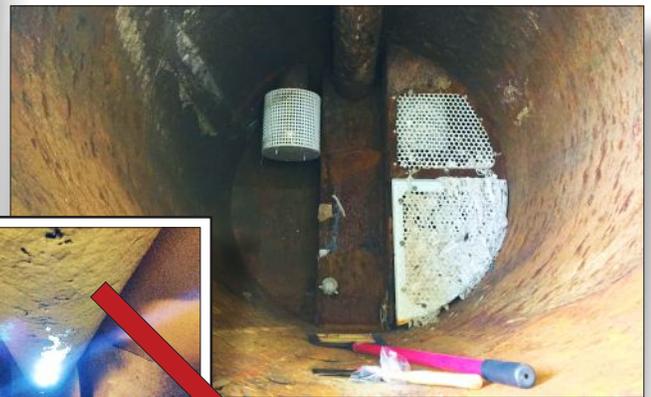
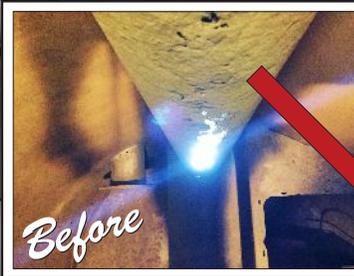
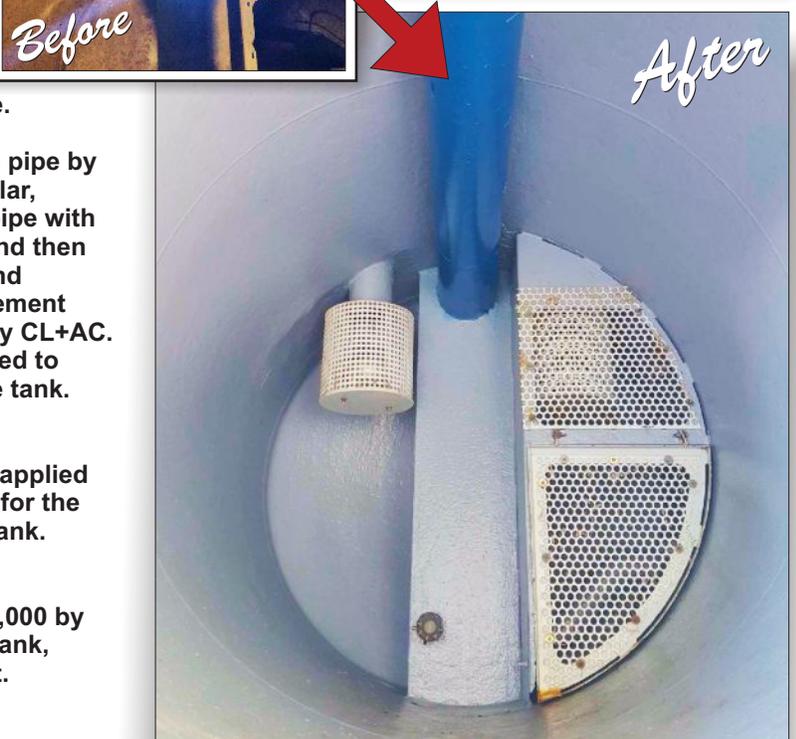
A Florida municipality which uses ENECON products for many of their repair and preventative maintenance needs had a problem that needed to be solved. A 1,500 gallon steel vacuum truck tank's interior was completely rusted and in desperate need of a solution.

The application began by manually removing all the pack rust, then the entire tank was grit blasted and cleaned. An inspection revealed numerous holes in the tank wall and significant failure to the main 10" diameter x 7' long suction pipe in the top of the tank.

The main suction pipe is continuously welded to the

interior tank wall, so wrapping the pipe was not possible.

ENECON repaired the pipe by fabricating a steel collar, coating the existing pipe with CeramAlloy CL+AC and then coating the interior and exterior of the replacement collar with CeramAlloy CL+AC. DurAlloy was then used to repair the holes in the tank.

Finally, two coats of CHEMCLAD SC were applied to provide protection for the entire interior of the tank.
