ENECRETE WP & WS Solve Leaking Elevator Pit Problems for National Hotel Chain

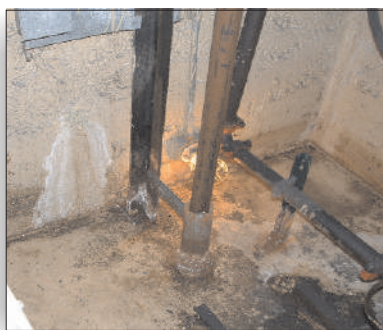
The project became very involved because there was a great deal of oil and a very thick existing coating that had been pushed deeply into

numerous crevices and holes in the concrete. It took 5 workers, 2 days to remove the existing coating using needle guns. The problem was so severe because the elevator pit was not made of cinder block, but instead, it was a poured concrete pit - poured in 3 sections allowing gaps and crevices to form between each pour.

Elevator Pit Before

We used 2 units of ENECRETE WP and 8 units of ENECRETE WS, coating four feet up the pit walls.

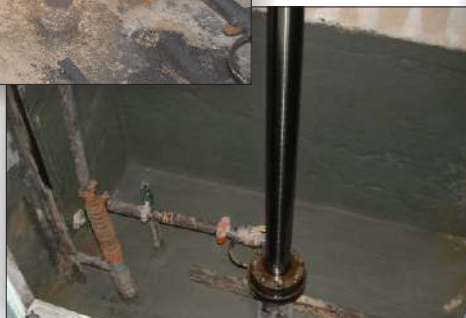
After

The project was completed on time. The client and the State inspector were both very pleased with the results."
