DuraQuartz & CHEMCLAD XC Seal Leaks In Hospital Kitchen Floor

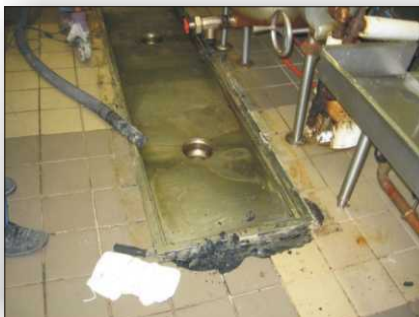
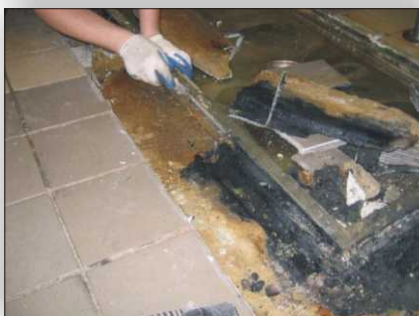
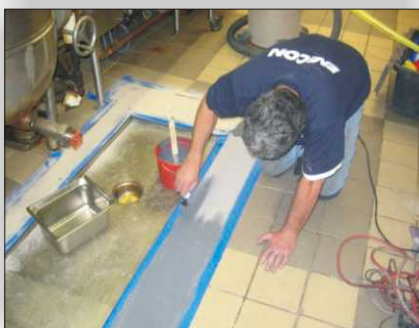
The first course of tile around the trough was carefully removed and the true source of the problem was revealed. The underlying thin set mortar and concrete was severely deteriorated by water and food acids.

After damaged materials were removed, DuraQuartz was applied to provide a smooth transition from the quarry tile floor to the rim of the trough.

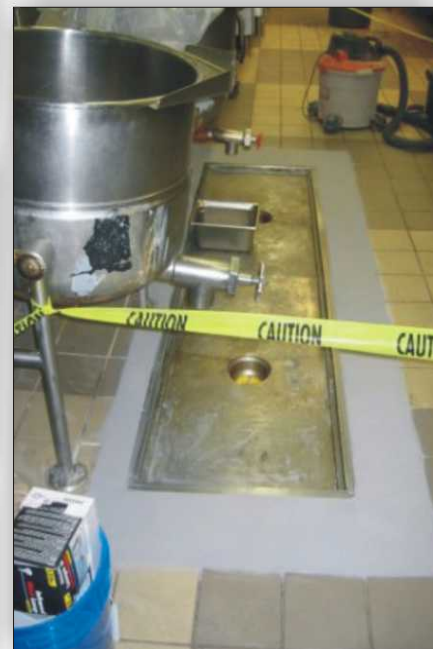
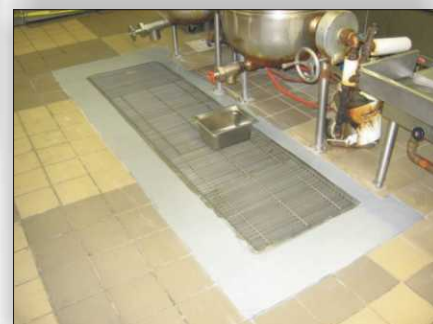
two layers of CHEMCLAD XC, incorporating an anti-slip aggregate, were applied over the DuraQuartz.
