ENECRETE & ENESEAL Bring Degrading Hospital Staircase 'Back to Life'

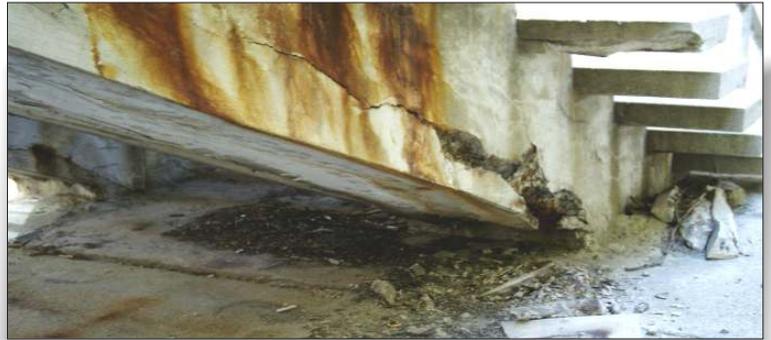
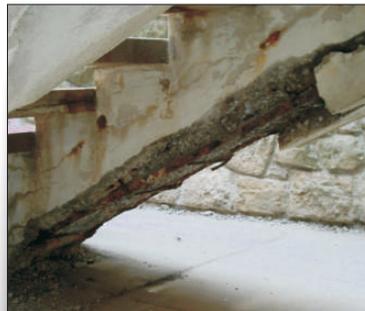
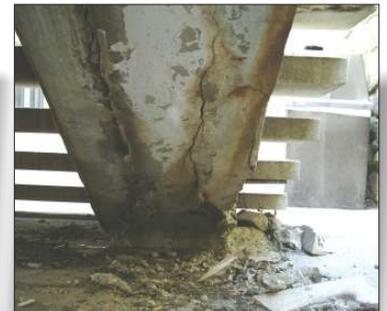
This prestigious medical center located in the Northeastern U.S. had a severe problem with their main entry steps. Replacing them was not an option as they were an important part of the hospital's classic 1950's style of architecture.

After determining that the steps were structurally sound and not a danger to the public, the hospital's engineers then needed to find a cost effective, viable repair and protection system. The local ENECON Engineering Specialist was contacted.

He recommended that a combination of *ENECRETE DuraQuartz* and *DuraFill* as well as *ENESEAL CR* be used over a 5 day period to repair and protect these steps.

After thoroughly cleaning the substrate, *DuraQuartz* was first used to rebuild the deteriorating stair structure.

ENESEAL CR was then used to protect the concrete from further corrosion as well as create a uniform look. *DuraFill* was then used on the top of the step surfaces to provide a slip-resistant safety surface.

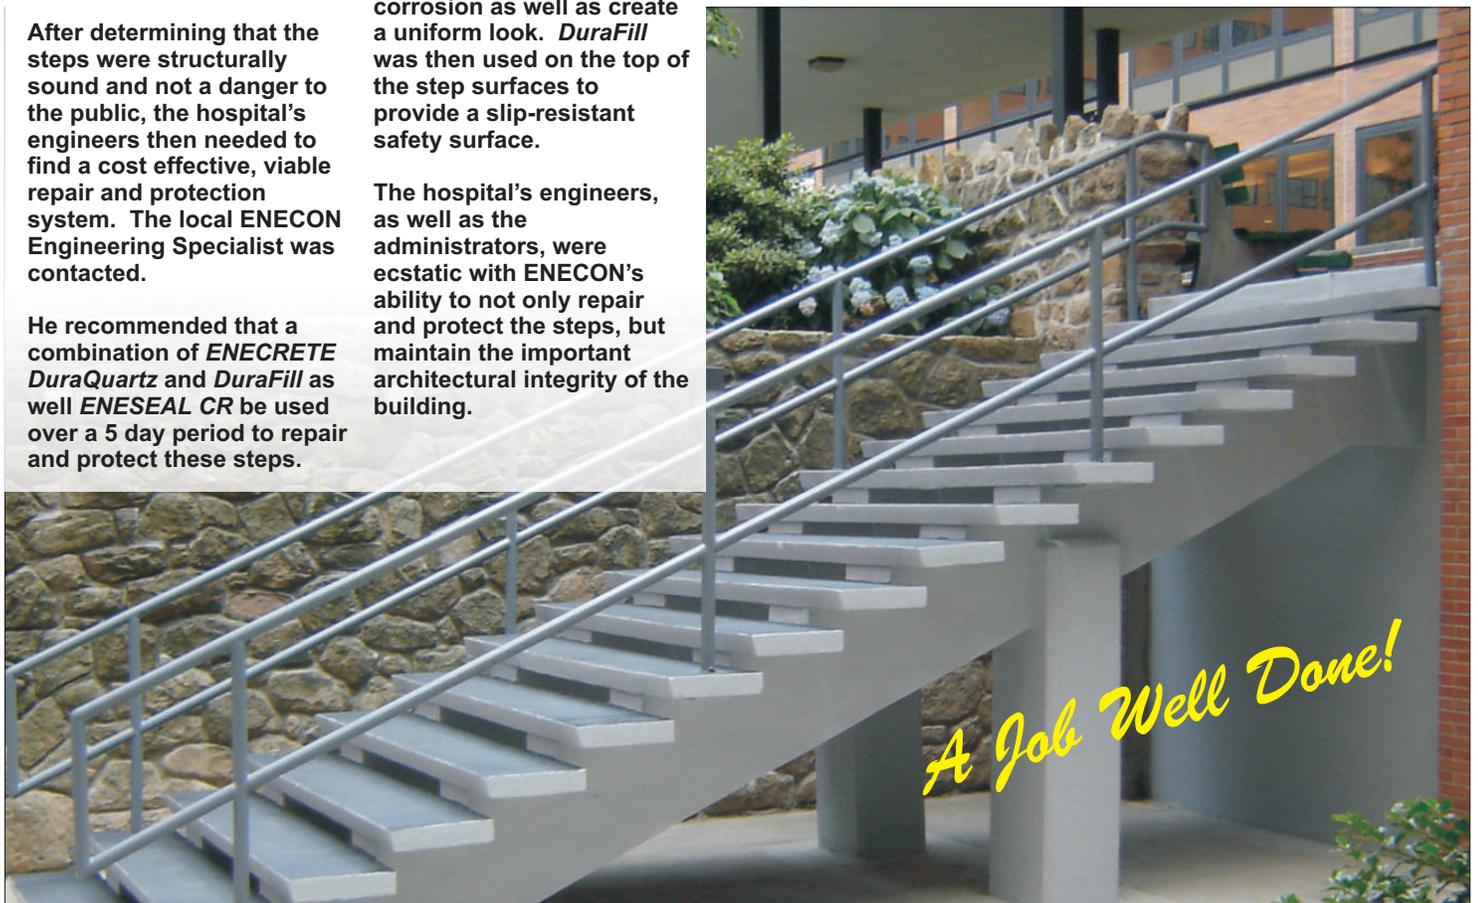
A Job Well Done!

The hospital's engineers, as well as the administrators, were ecstatic with ENECON's ability to not only repair and protect the steps, but maintain the important architectural integrity of the building.
