## ENECRETE DuraFill & CHEMCLAD XC Salvage Floor at Polish Food Plant

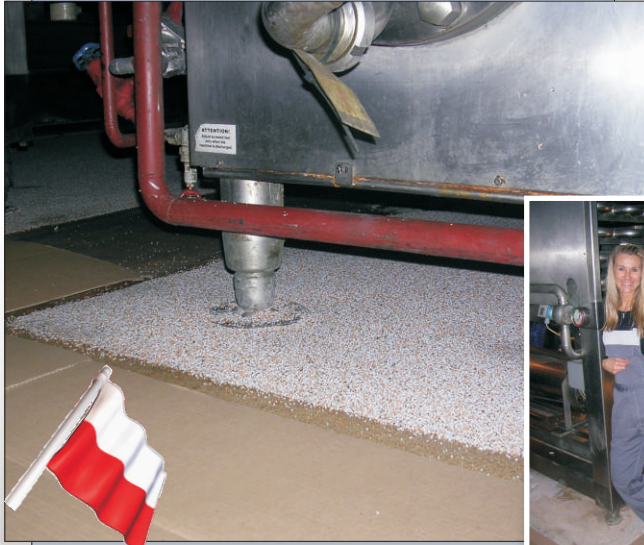
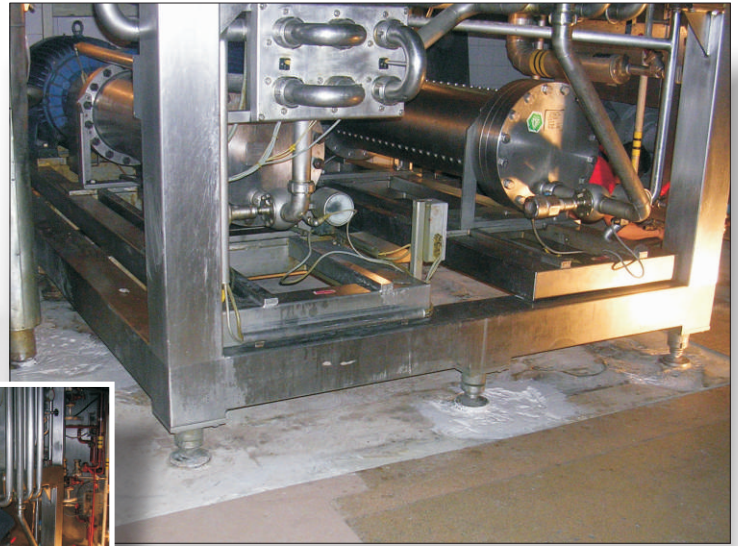
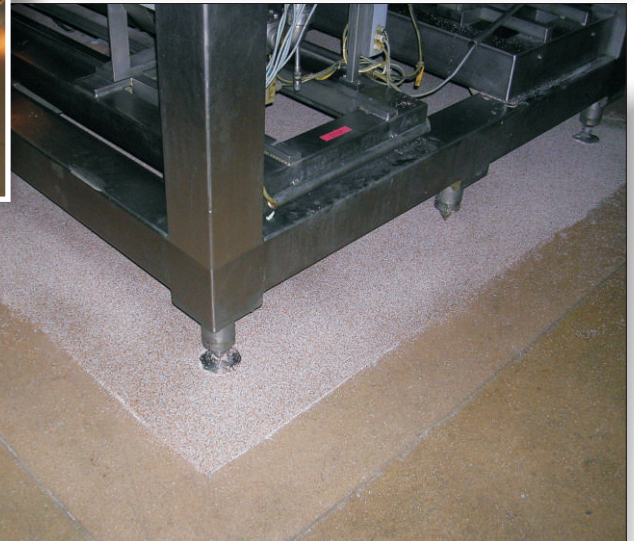
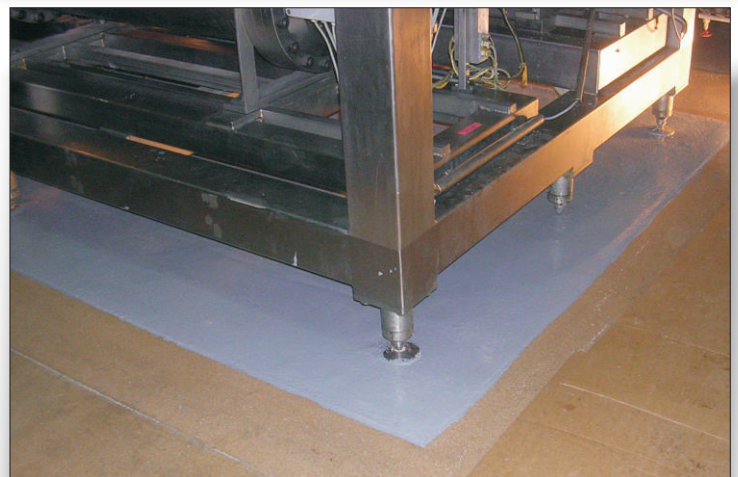
This large, international margarine producer, located in Poland, had a severe problem with some of their floor areas. These areas, which were under processing equipment that *could not be moved*, had deteriorated due to the aggressive chemicals that continuously drop on the concrete floor.

They recommended cleaning the areas and then pouring out ENECRETE DuraFill mixed with locally sourced fine aggregates. Then two coats of CHEMCLAD XC were applied to provide long-term chemical protection to these floor areas.

The entire project took just 7 days to complete with minimal disruption to plant operations.
