## University Repairs & Protects Interior Staircase With ENECRETE<sup>®</sup> DuraQuartz<sup>®</sup> & DuraFill<sup>®</sup>

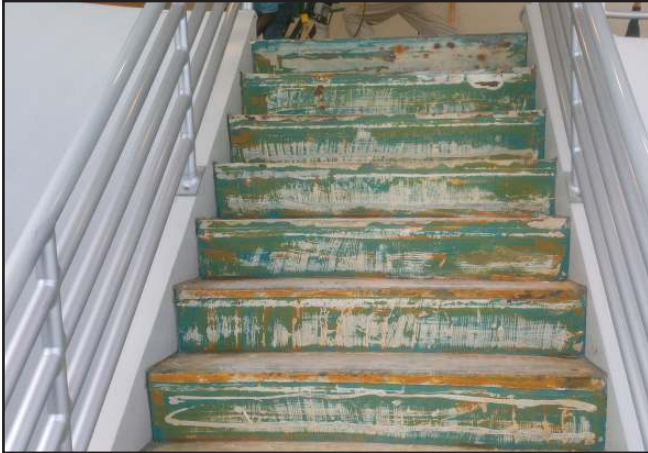
This indoor atrium staircase at a prestigious eastern U.S. university was falling into disrepair. The old vinyl tiles were detaching from the substrate causing an eyesore as well as safety concerns for students and faculty alike.

The vinyl tiles were manually removed from the staircase. The tile's

mastic was then mechanically removed from all areas and the metal step substrate was roughened.

**ENECRETE DuraQuartz** was used to repair any damaged areas followed by a two coat system of **ENECRETE DuraFill** with an aggregate broadcast for slip resistance in this high foot traffic area.
