## 150 Year Old Cemetery Patio Repaired & Protected With ENECRETE

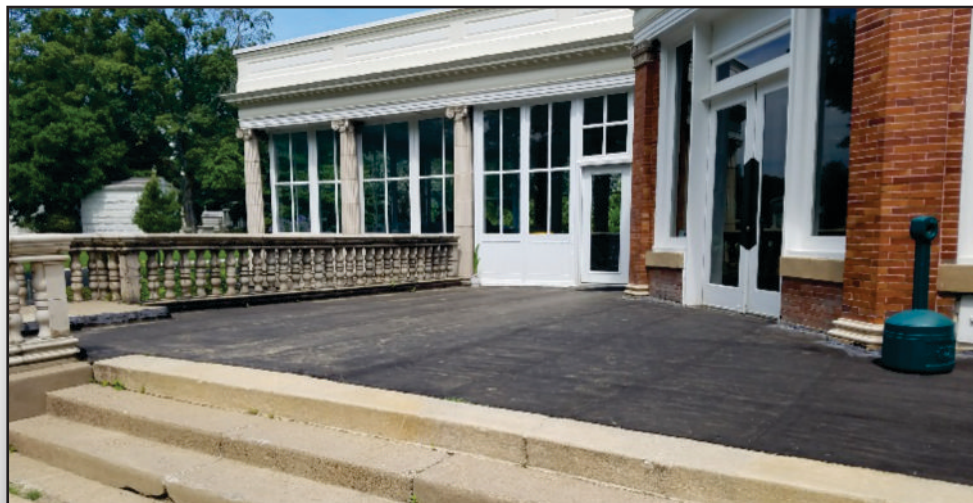
This 150 year old tar covered concrete patio just off the main building at a Pennsylvania cemetery was showing signs of its age. Several areas had uneven surfaces, cracks and gaps which were causing leaks into the storeroom below as well as creating dangerous trip and fall hazards.

Multiple tar and paper layers on top of the concrete patio had to be removed. This proved to be very difficult in some areas requiring the use of shingle scrapers, mechanical cutters, grinders and even heavy equipment.

The area was thoroughly cleaned and vacuumed and DuraFill, mixed with locally sourced quartz sand, was troweled to repair the surface of the concrete and create a proper 'grade' in some areas. Two coats of DuraFill with a sand broadcast were then applied as a top coat.
