## ENECRETE DuraQuartz Light Weight Provides A Simple Solution To A Complex Problem At A Louisiana Public Works Station

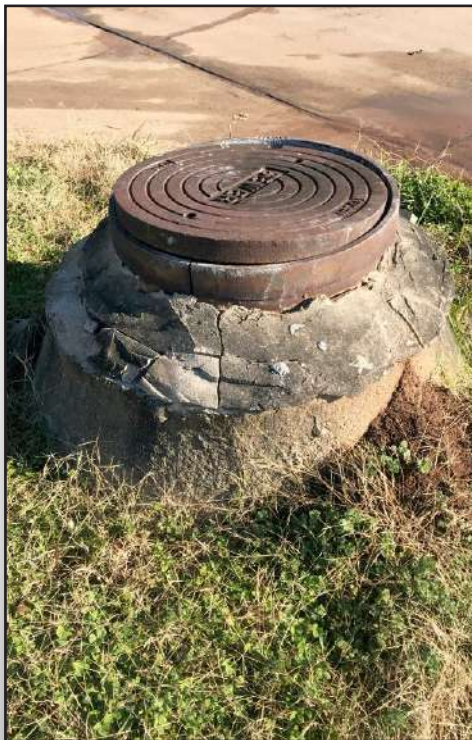
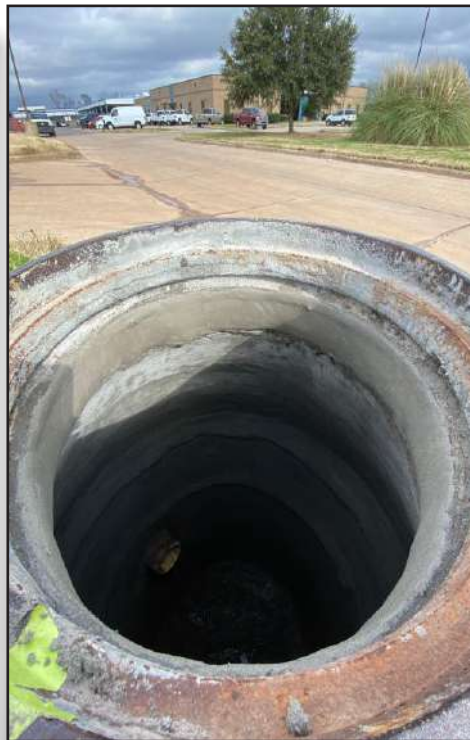
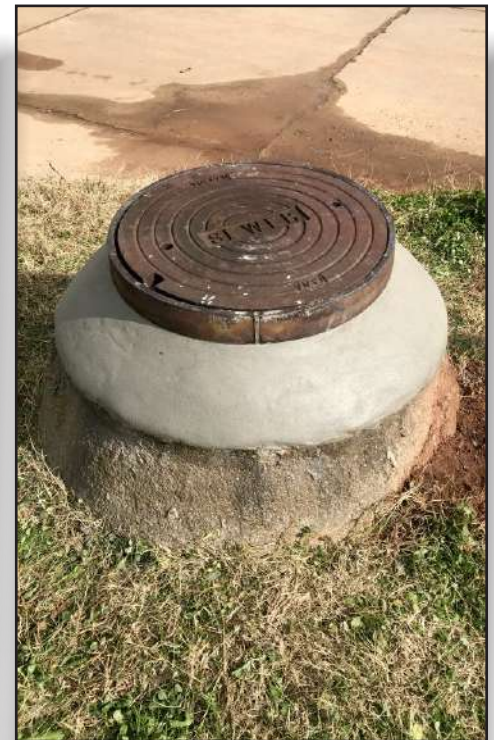
A Louisiana public works station was trying to fix a broken manhole cover base. This base had been hit repeatedly by grass mowing equipment. Not only was the outer support concrete broken, but the cover was knocked off center of the base by the weight/speed of the mowers.

The cover and seat rim were removed along with any broken or damaged concrete down to the area just above the ground. Any remaining debris was removed and the area was cleaned. A high-build bed of DuraQuartz LW was laid down on the base and the cover and seat rim were placed on it, properly centered. The inside of cover seat rim was also lined with DuraQuartz LW.

This repair job completed in one day by the onsite maintenance team after consulting training from the ENECON Specialist.
