## Prestigious Hospital in Montreal Solves Serious Safety Problem With a SuperBond Non-Skid System

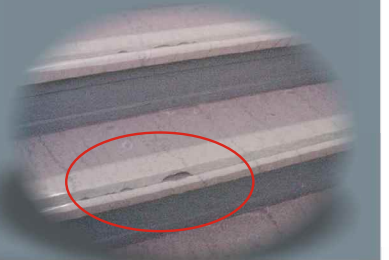
The ENECON Distributor in Montreal, Martin DeSerres, was confronted with a difficult problem. The conventional non-skid tape on these marble steps at a local hospital was constantly coming up due to the very heavy traffic on the stairs. Repeated attempts to re-apply these tapes proved ineffective.

The answer? ENECLAD SuperBond coupled with a fine aluminum oxide aggregate. After a thorough detergent cleaning, the area was dried, masked-out and SuperBond was applied. An aluminum oxide aggregate was then tamped into the SuperBond and the area was allowed to cure for 24 hours.
