Leading Hotel in Malta Reduces Mineral Scale Problem with ENEFLOW

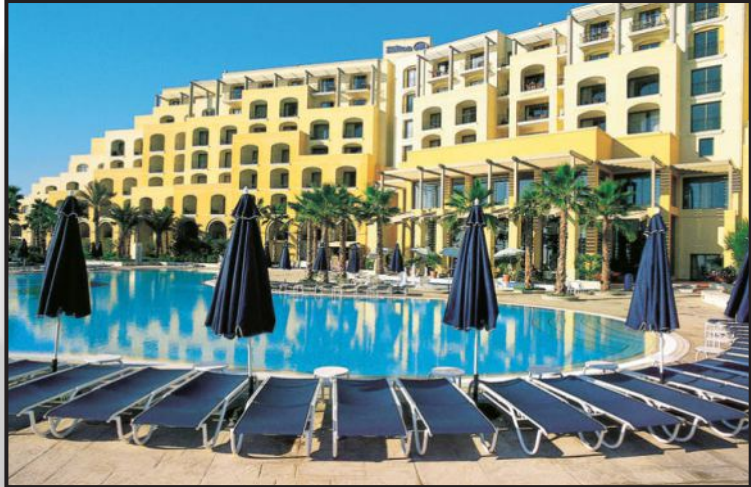
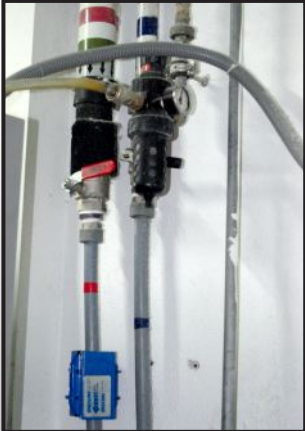
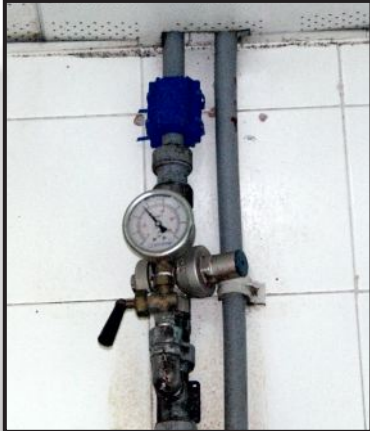
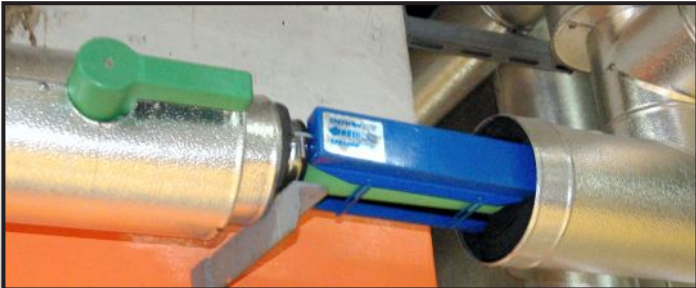
A local dealer for ENECON Italia in Malta, recently completed a long-term test with ENEFLOW at a major international hotel chain. ENEFLOW was installed on multiple water lines that were experiencing significant mineral scale problems.

They recorded a 38% reduction in the thickness of scale in the

clarifier check valve - 74% of the overall reduction in scale took place in the first 56 days.

Significant improvements were also seen in the dishwasher lines.

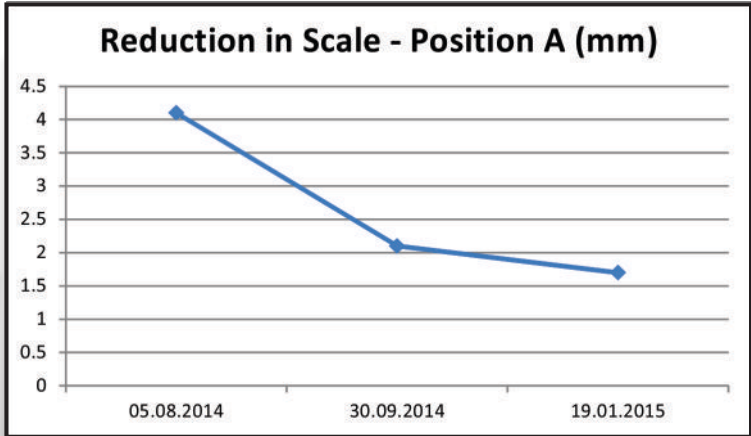
Scale measurements at 2 different positions show reductions in scale over time.
