## Power Station Solves Nagging Leakage Problem With ENESEAL HR

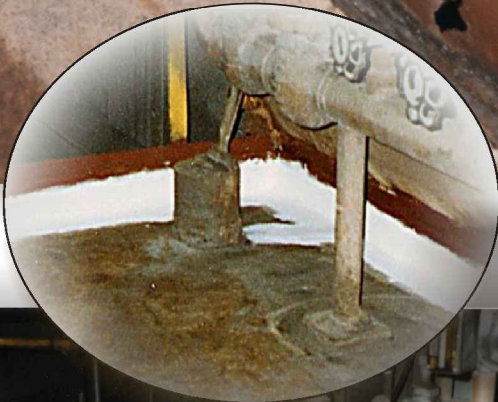
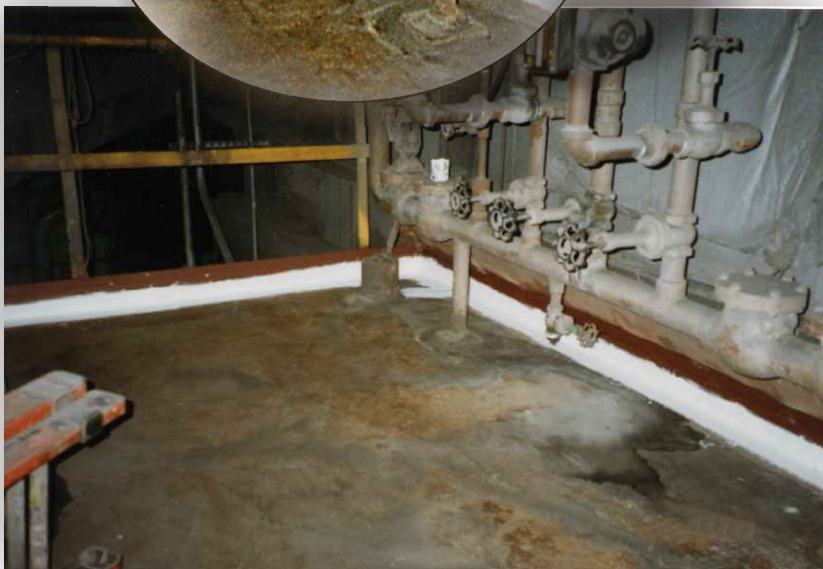
A concrete deck area - bordered by a metal curb - was subject to liquids splashing and collecting around the edges.

Over the years, a number of attempts at curing the problem by conventional means proved to be effective for only a short time.

In addition, time - and corrosion - had made holes in the metal edging, making continuing such attempts futile.

After preparing the surfaces and priming the steel, the ENECON Field Engineer used polyethylene tape to "bridge" the gap and create a smooth transition between the curb and the floor.

Then, using fiberglass mesh to reinforce the repair, the **ENESEAL HR** was brushed on to completely seal the joint and prevent further leakage.
