This factory roof in Ontario, Canada, was experiencing leaks, big and small, through their 40+ year old roof. This is a built up roof or “BUR”, which is tar & gravel on top of insulation laying on corrugated sheet metal. There are over 20 million square feet of roofs at this facility!

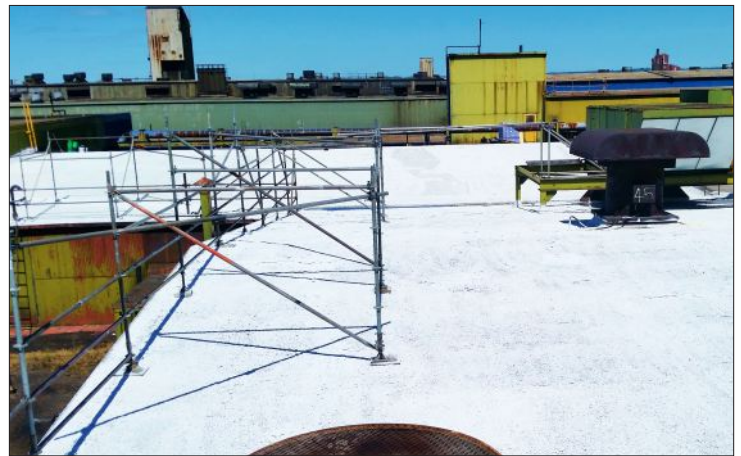
The gravel layer on the roof was extremely difficult to remove.

Many areas had several inches of dirt and gravel which had to be removed using shovels, sweepers, blowers and vacuum trucks.

Once clean, the roof surface revealed hundreds of holes, cracks, splits and seams. A specialized tape was used for spot patching, followed by 3 – 5 coats of ENESEAL HR. The application was done by brush, roller and sprayer.
