An area where these roof top air circulation pipes converge to enter a university building was vulnerable to leaks from rainwater. When this area leaked, water would drip down to laboratories below filled with expensive equipment.

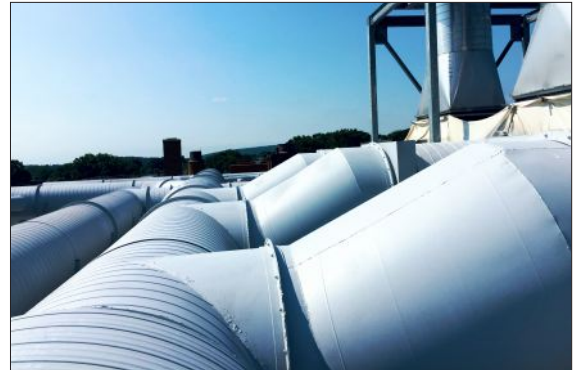
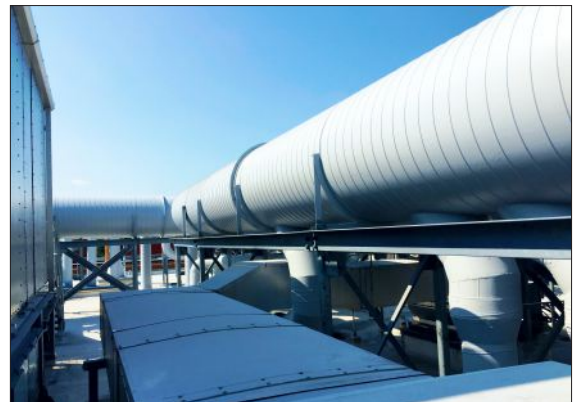
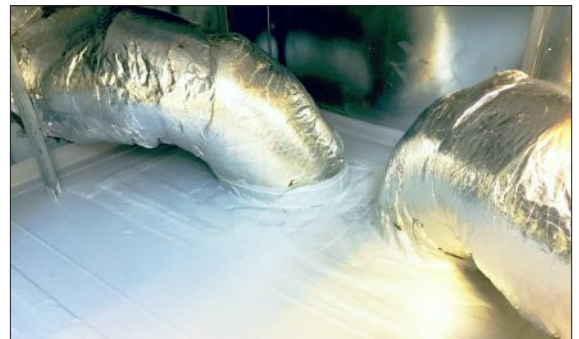
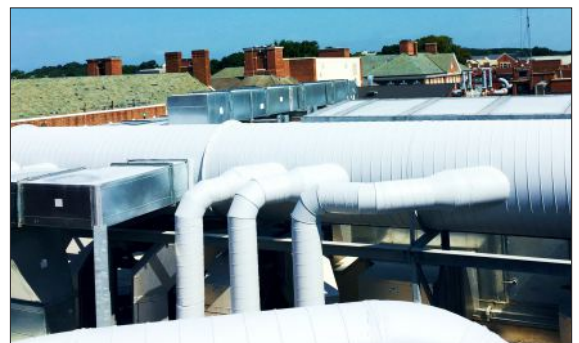
After...

The ENECON solution solved the leak problem and the university maintenance team is extremely happy. The local ENECON Engineering Specialist is now looking at other similar solutions on campus.

It was decided that all the joints would be sealed with specialized joint sealing tape followed by spray applied two coats of ENESEAL CR.

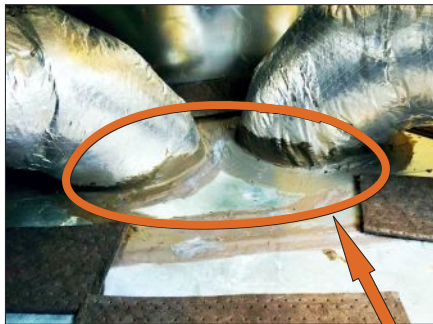
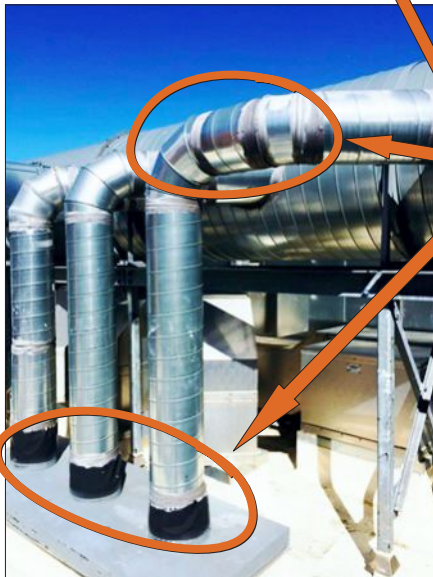
Before...

The pipes are spiral wound stainless steel, so corrosion is not a problem, however rainwater was entering the pipes through the pipe-winding joints.

Earlier spot repairs circled in the before photos were not effective. The university maintenance team needed a better solution.
