FLEXICLAD ER[®] Repairs Rubber Covered Drive Shaft at Wastewater Treatment Facility

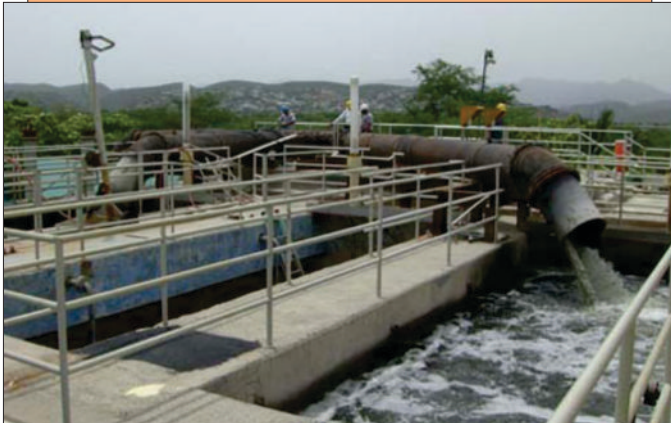
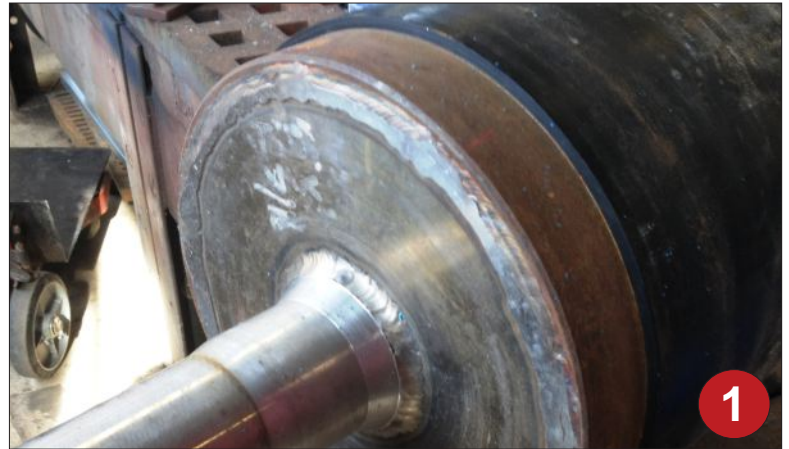
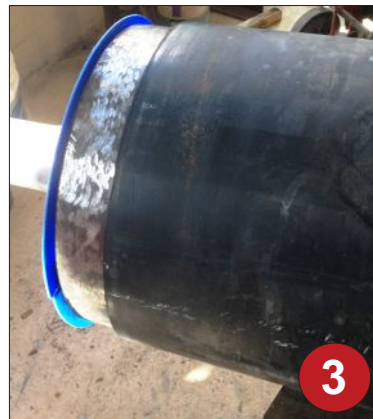
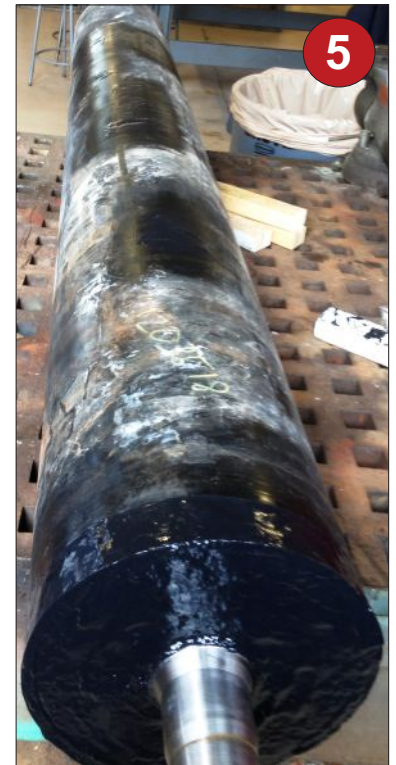
The end of this 10 inch diameter drive shaft, used on the belt system for de-watering the 'floc' at this wastewater treatment facility, had to undergo some welding repairs. The existing rubber shaft covering had to be cut back to allow for the welding process.

The plant engineers needed to get the system running so they turned to their local ENECON Field Engineering Specialist for help. He suggested using FLEXICLAD ER to rebuild the exposed end – providing a seamless rubber finish on the shaft.

A plastic former was created (an ENECON mixing board was used for this) to help in the rebuilding process. After grinding the metal, a ¼ inch layer of FLEXICLAD ER was applied to re-finish the shaft end. After 30 minutes, the former was removed and more FLEXICLAD ER was applied to complete the repair on the exposed end of the shaft.

This entire project was successfully completed in just one day saving the plant thousands of dollars in down-time associated with conventional rubber repairs which would have taken 3+ weeks.
