Super Job on this Super Titan in Australia

ENECON's Australian Engineering Team came across this Super Titan pump at one of the largest copper mines in the world.

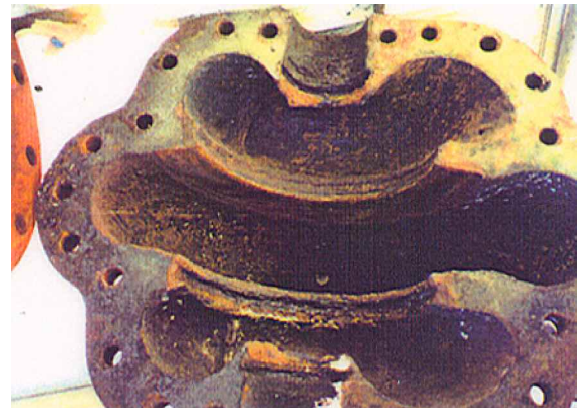
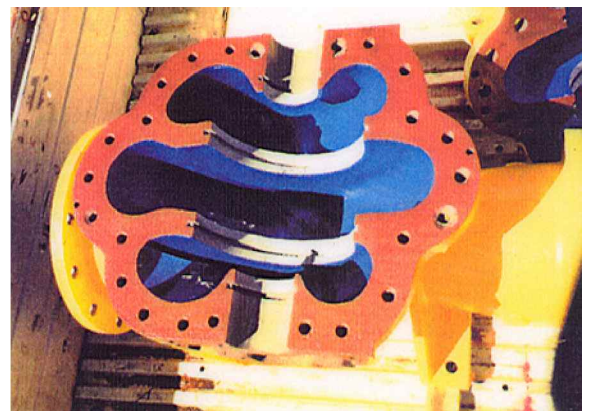
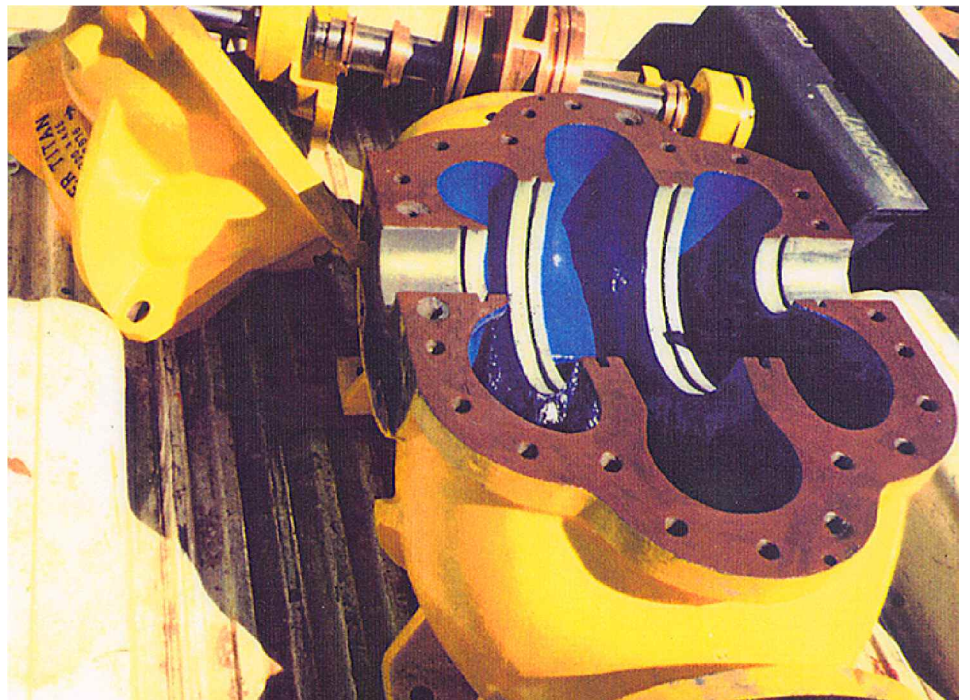
Severe erosion and corrosion from copper sulfate had taken its toll. So much so, in fact, that this **\$20,000 casing** was found in the **scrap heap!**

The photos clearly show the "**picture perfect**" results. And, the total cost of rebuilding - including multiple blastings, all labor, materials, reassembly, etc. - was **less than 25% of the replacement cost of the casing!**

The level of ingrained contaminant required grit blasting and "leaching" the casing **6 times** prior to any materials being applied. The wear ring areas required build-ups of 10 to 15 mm (about one-half inch) using **CP+**. Tolerances were especially critical since the plant required a running clearance of 0.005".

All the "wet areas" were then treated with **CeramAlloy CL+** to completely protect the casing from the accelerated attack it will be subjected to when returned to service.
