Spanish Nuclear Station Chooses CeramAlloy & DuraQuartz To Control Corrosion On Cooling Water Intake Lines

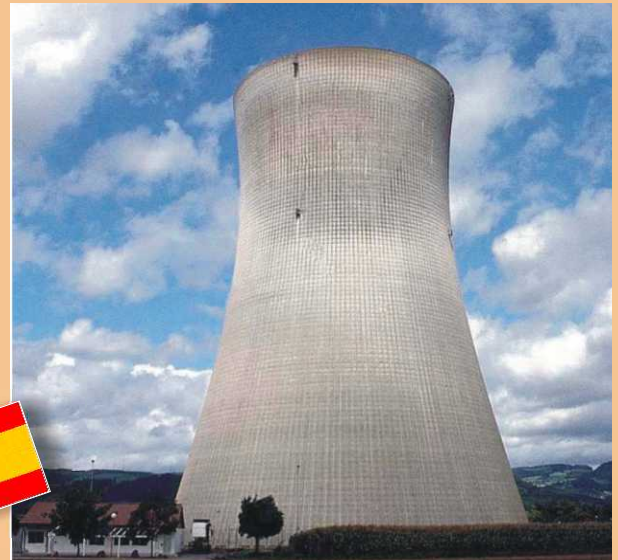
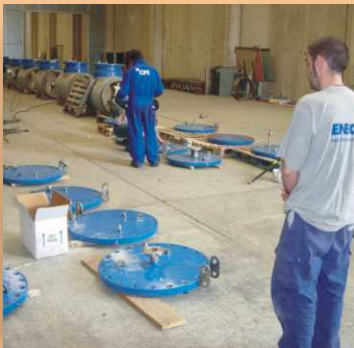
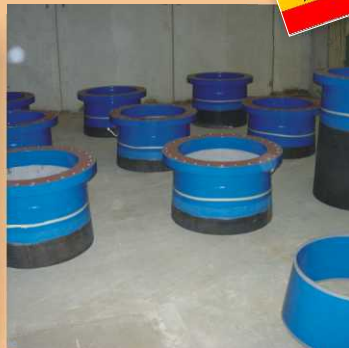
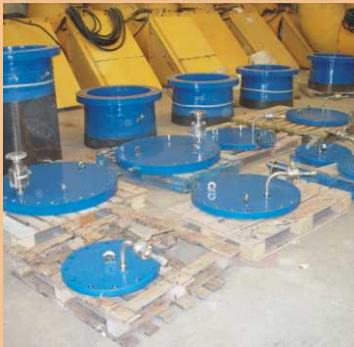
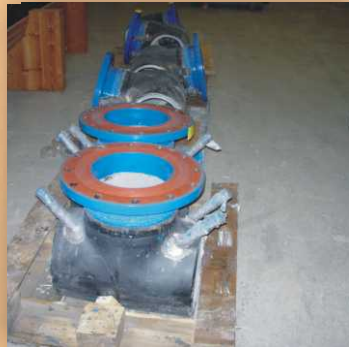
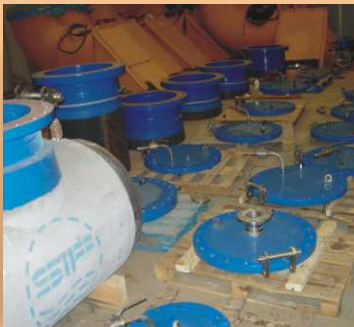
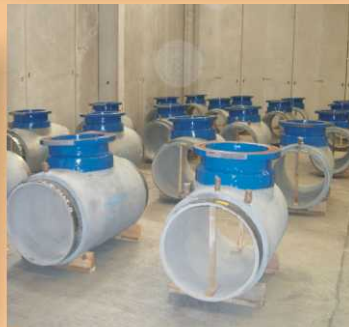
The maintenance engineers of this major nuclear power station were experiencing problems in their cooling water intake lines due to ineffective seals on the access manhole collars. The metal intake piping is encased in concrete and the existing design was allowing water to seep between the concrete shell and the metal core. This caused corrosion on the outside of the metal pipe.

The local ENECON Ibérica specialist building up the joint between the metal collars and the concrete casing with DuraQuartz to prevent the water from getting behind the seal. After the DuraQuartz was applied, the collars were coated with two layers of CeramAlloy CL+(AC) to complete the application.

Upon reassembly, the station engineers were completely pleased when they saw that the leakage had been stopped and the corrosion problem eliminated.
