Waste Water Treatment Facility Saves Main Sewage Pipe

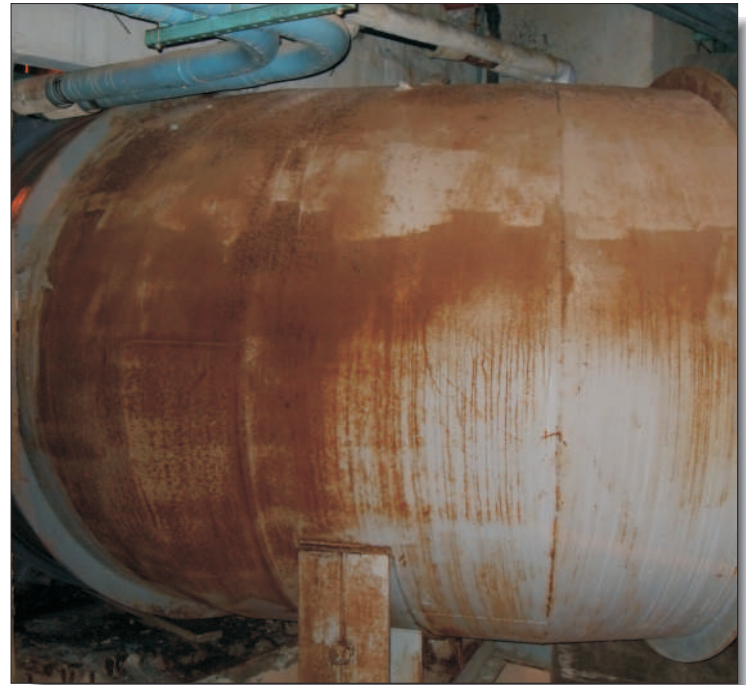
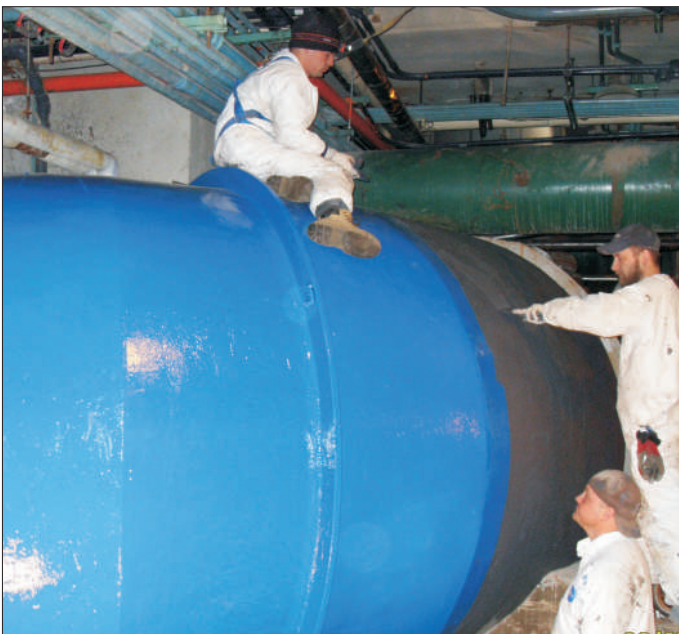
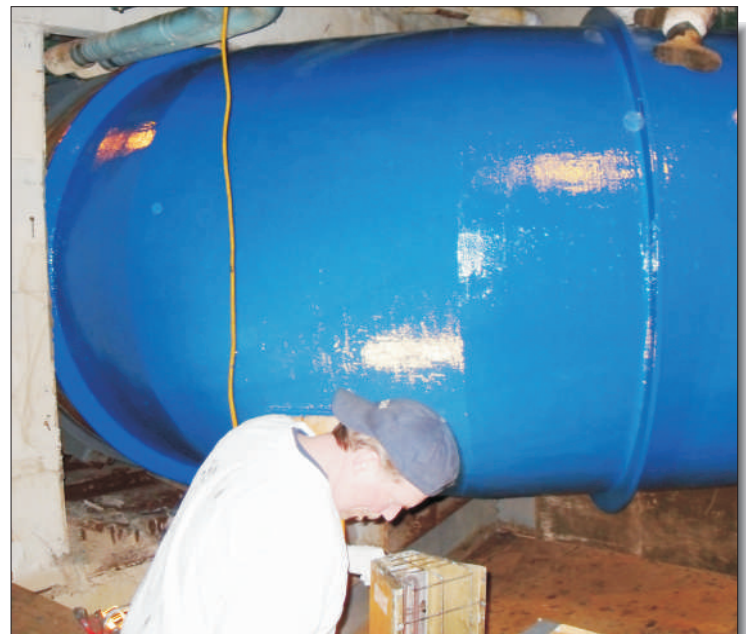
This 96 inch raw sewage force main, located at a waste water treatment facility in the Northeastern United States, had been eroded internally due to years in service.

Faced with the threat of leaking raw sewage, the plant engineers contacted their local ENECON Field Engineer to provide a solution. After careful inspection, as much as 1/3 of the pipe's thickness in some places had been lost to erosion.

Fearful that grit blasting may cause further damage, the pipes were roughened mechanically.

An application of **CeramAlloy CP+AC** and **CeramAlloy CL+AC** was carried out followed by a wrapped layer of fiberglass mesh to reinforce the repair and enhance the pipe's structural integrity. A second application of **CeramAlloy CP+AC** and **CeramAlloy CL+AC** was then applied to complete the repair.
