Major Power Plant Located in the Northeastern U.S. Selects CeramAlloy Pipe Wrap System to Repair this Main Cooling Water Intake Pipe

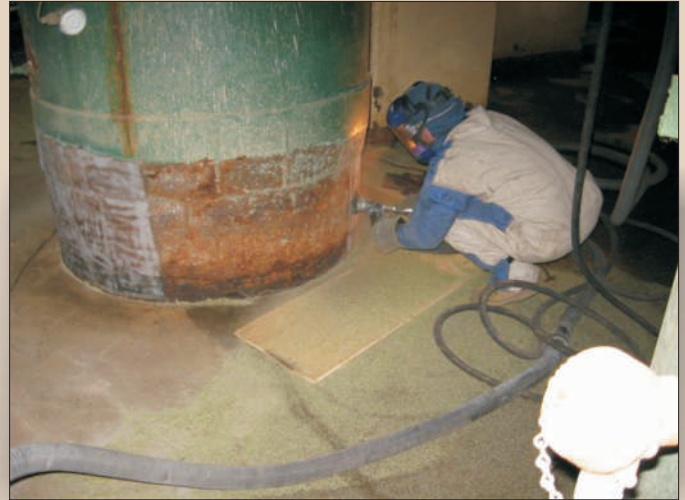
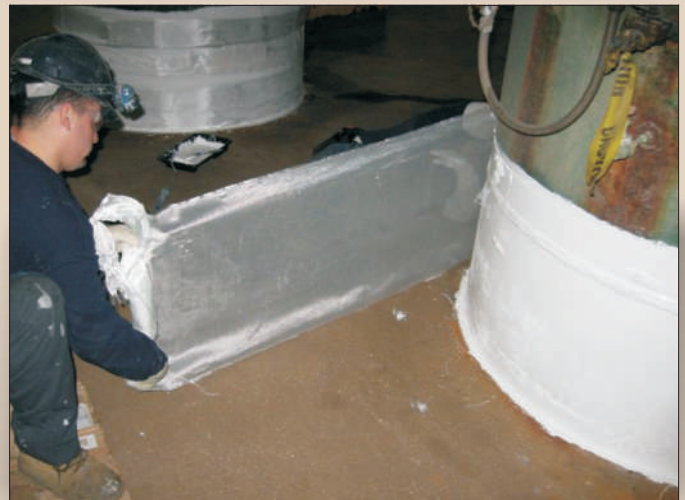
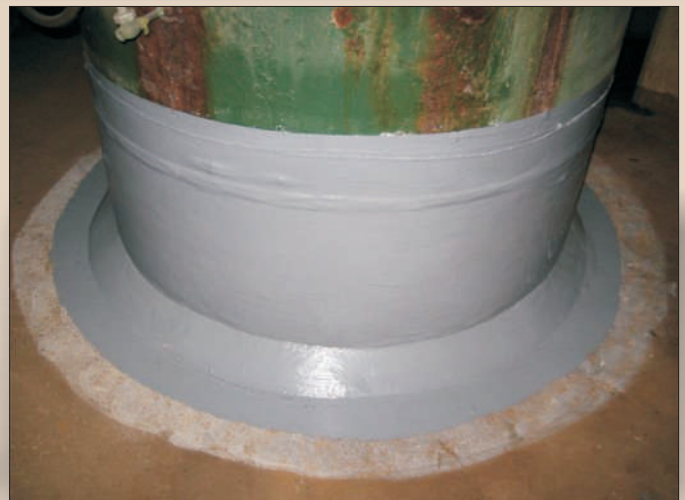
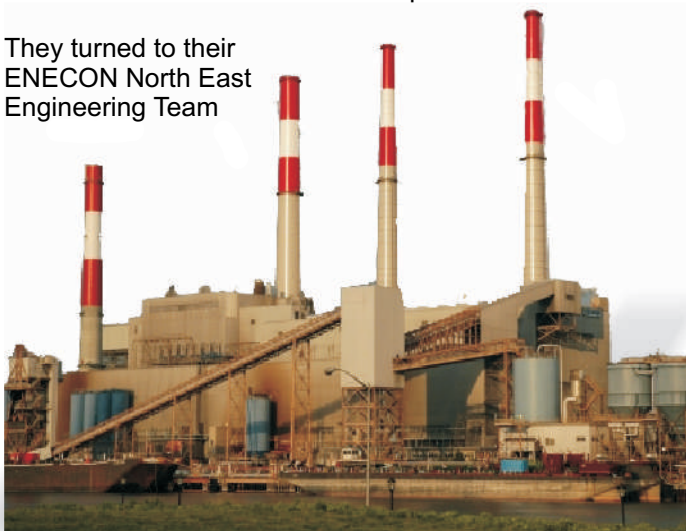
The maintenance engineers at this large oil fired power plant needed an unconventional approach to repairing and reinforcing a damaged section on one of their main cooling water intake pipes.

They could not shut down the plant for an extended replacement procedure and they were concerned that a conventional welding repair could damage the pipe further since it was already worn thin by years of erosion and corrosion attack in the brackish water environment.

After preparing the surface by grinding and wire-brushing, **SuperBond** was applied to insure optimum adhesion. This was followed by the application of multi layers of **CeramAlloy** and special reinforcement cloth to completely encapsulate this pipe section, thus providing a long-term repair. This \$10,000 project took just a couple of days to complete.
