ELECON® NEVS

The propeller shafts on this Croatian Naval ship were suffering from severe erosion / corrosion in the areas around the struts and before the propellers. This was due to many years of operation in a harsh salt water environment.

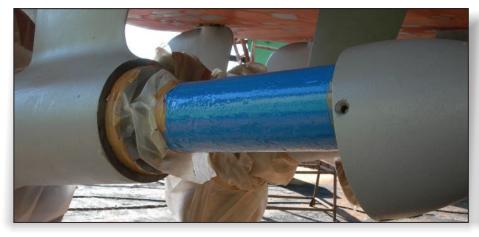
Previously applied epoxy coatings had failed and the ship's engineer was looking for a long lasting, cost effective solution.

ENECON Croatia
was contacted and it
was recommended
that a combination
of CeramAlloy
CP+AC and CL+AC
be used to repair the
existing erosion /
corrosion damage
and to protect
against future
damage.

After first grit blasting the damaged areas, a layer of CeramAlloy CP+AC was applied to rebuild the damaged areas. Two final coats of CeramAlloy CL+AC were then applied.
