## Waste Water Treatment Plant Salvages 'Unsalvageable' Pump Suction Housing with CeramAlloy

**Client:** Waste Water Treatment Facility

**Location:** Southwest Florida

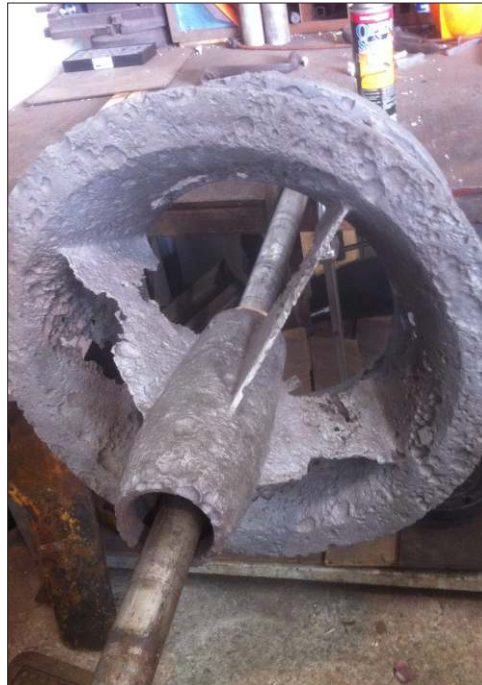
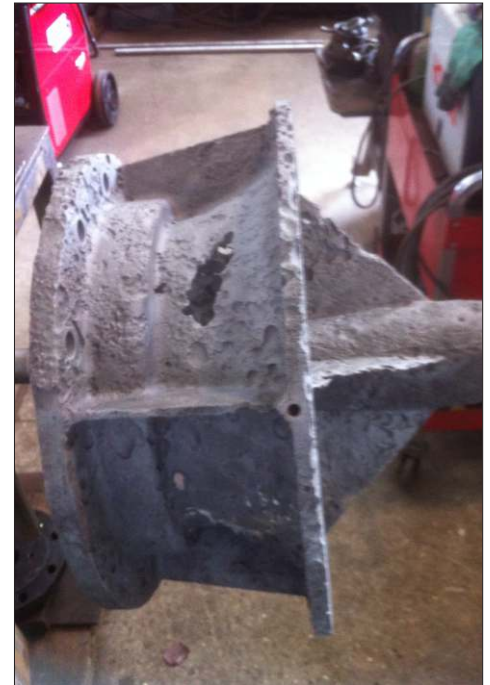
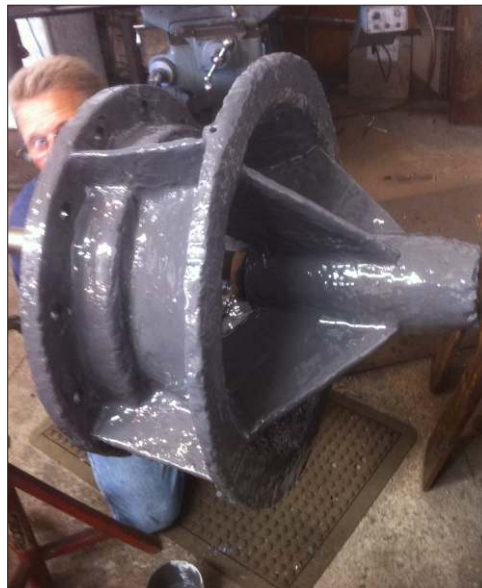
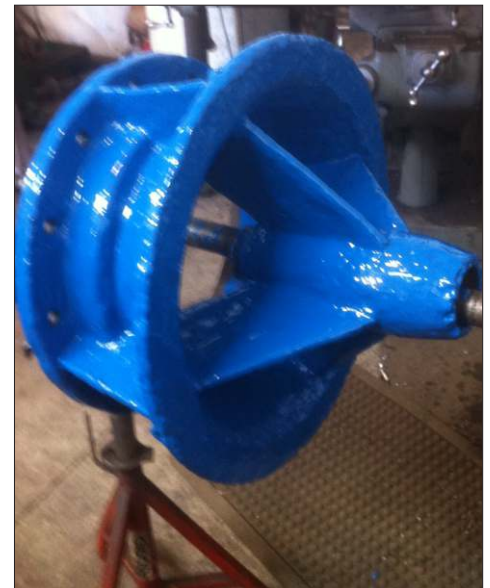
**Problem:** Severely eroded & corroded pump suction housing.

**Solution:** Grit blast – repair all eroded areas back to original shape and profile with CeramAlloy CP+AC. Reinforcement mesh was used to bridge holed or severely eroded areas. Two coats of CeramAlloy CL+AC were then applied to completely encapsulate the casing to protect it from future erosion and corrosion damage.
