Power Station Brings Salt Water Circulating Pump Back to Life

This utility in the northeastern U.S. reclaimed a damaged salt water circulating pump using METALCLAD CeramAlloy and some outstanding repair techniques.

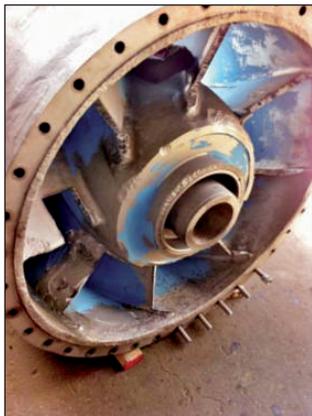
The severely eroded vanes were cut away.

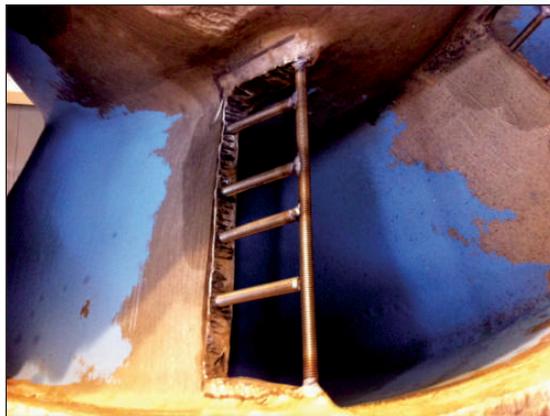
A threaded rod "skeleton" was installed by tack welding to the already cut vanes.

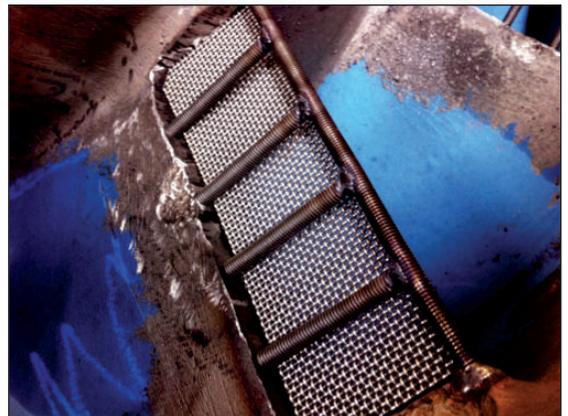
A heavy wire screen was welded onto the rods to provide reinforcement for the CeramAlloy.

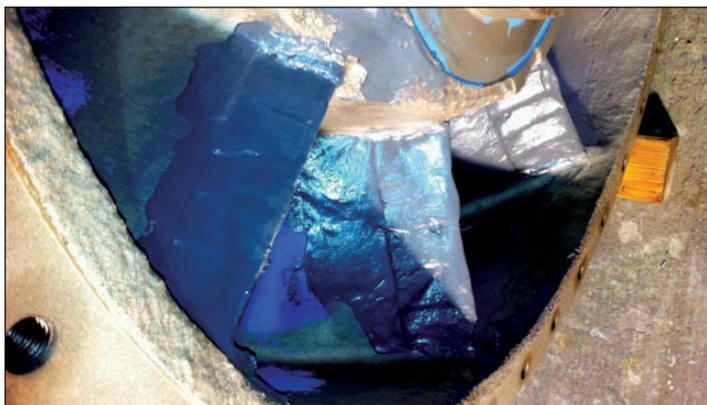
CeramAlloy CP+AC used to rebuild the vanes to their original size.

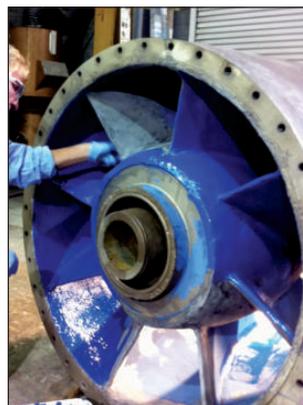
CeramAlloy CL+AC used to coat all surfaces.

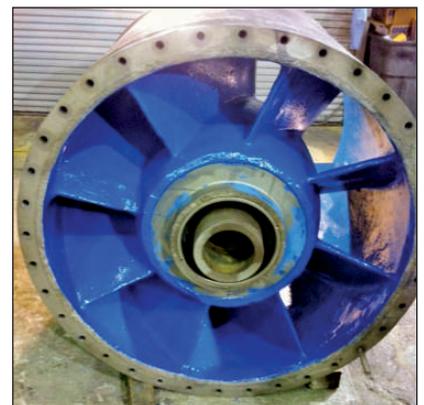
The completed component ready for service.
