## Chilean Hospital Pumps Brought 'Back to Life' with CeramAlloy<sup>®</sup> and CHEMCLAD<sup>®</sup>

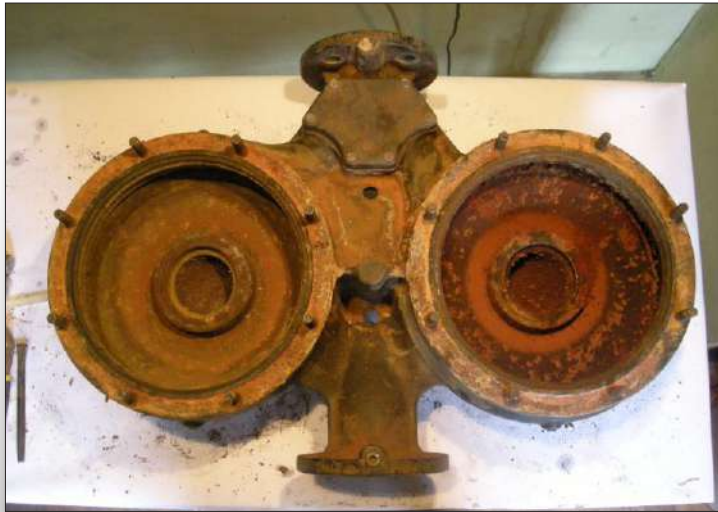
This hard water pump at a hospital in Chile was only averaging a few months in service before maintenance would have to be performed to repair deep erosion / corrosion damage.

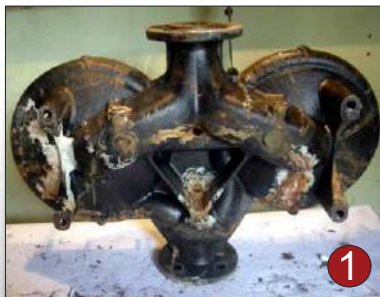
1. The pump casing before being refurbished.

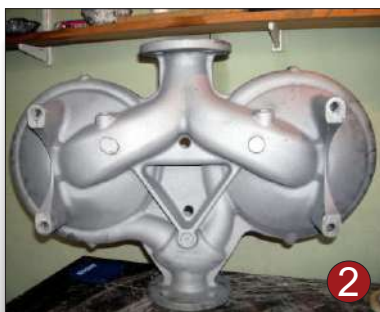
2. The pump casing after grit blasting.

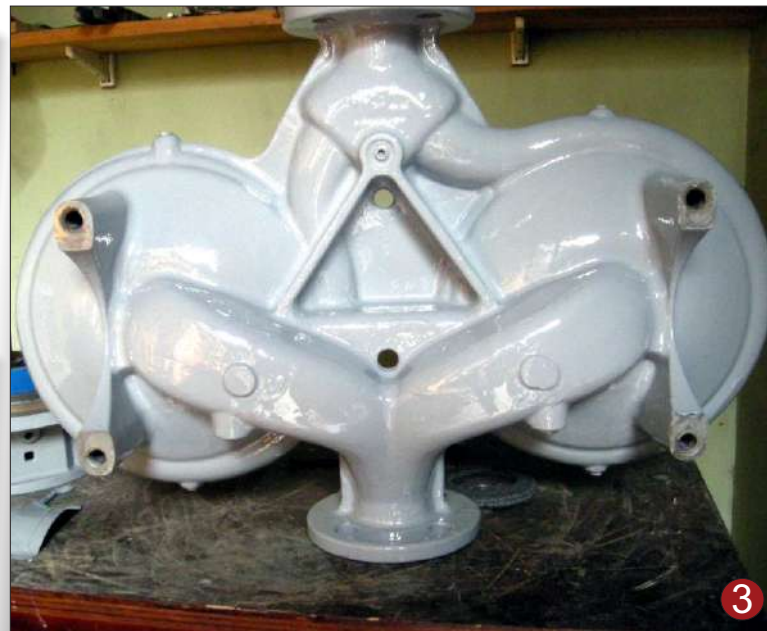
3. The pump casing was coated with CHEMCLAD GP which protects from future erosion / corrosion.
