## CeramAlloy Solves Erosion & Corrosion Problems on Panama Canal Tugboat Pump

At the Panama Canal, a fleet of tugboats assists ships passing through the newly expanded locks. Each of the tugboats have pumps like this one, which pump salt water.

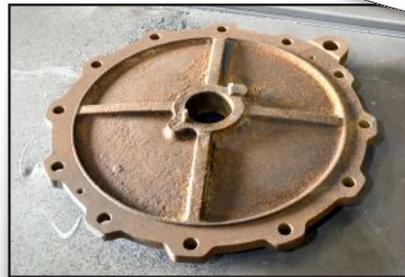
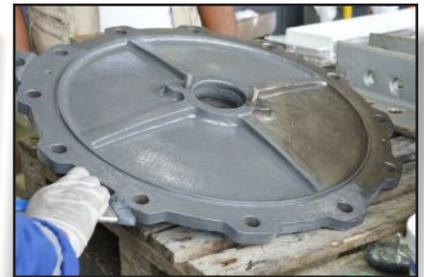
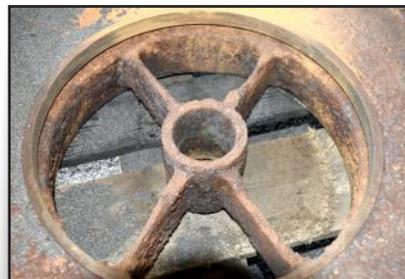
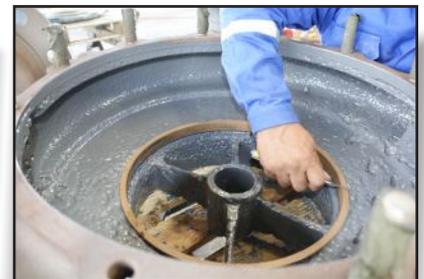
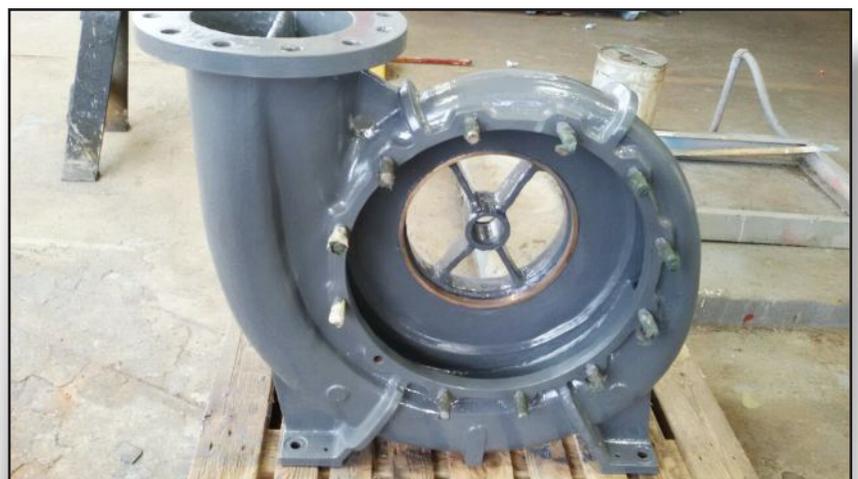
Constant exposure to salt water caused the entire surface of this pump to suffer from erosion and corrosion. This caused a weakening of the metal which then reduced the pump's efficiency in addition to leaks at the seams.

After grit blasting the pump and all of its components, a first coat of CeramAlloy CL+AC was applied to wet out all surfaces. CeramAlloy CP+AC was then used to rebuild the weakened and damaged areas. Then a final layer of CeramAlloy CL+AC was used to protect the pump from future erosion and corrosion problems.
