## Protection Of Internal Surfaces Of Waste Gas Cleaning Plant Exhaust Duct Using CeramAlloy HTL

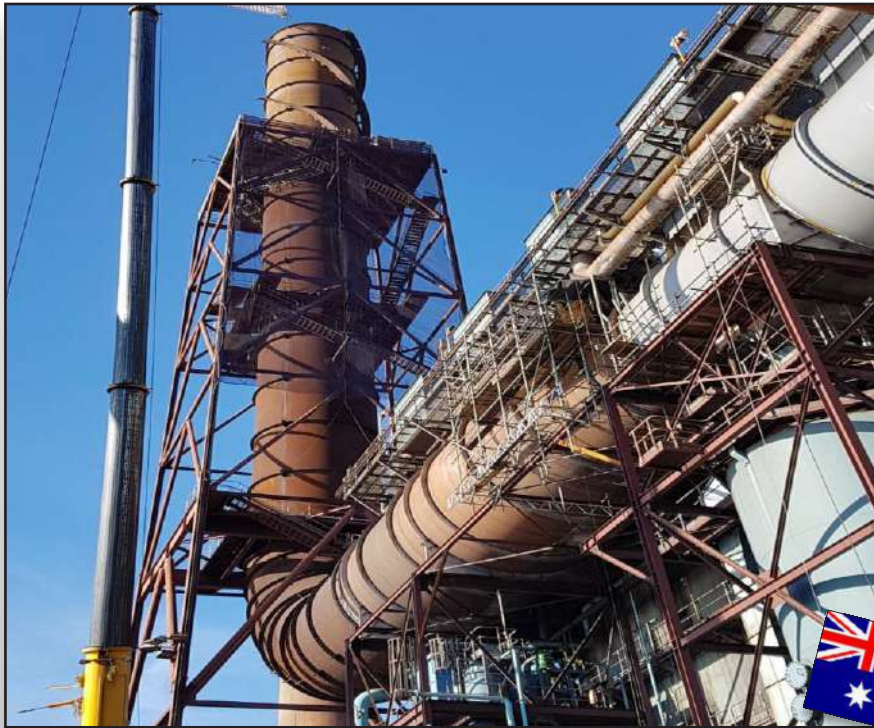
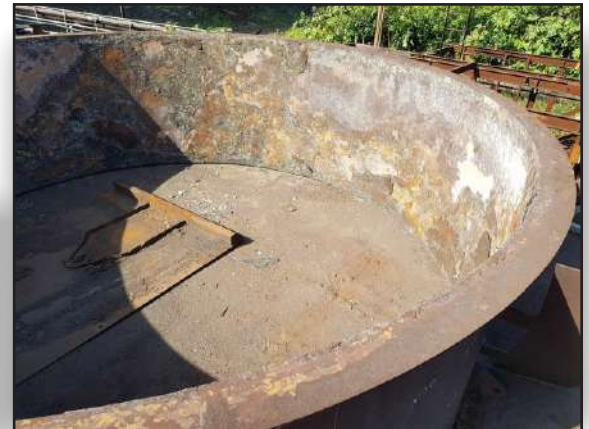
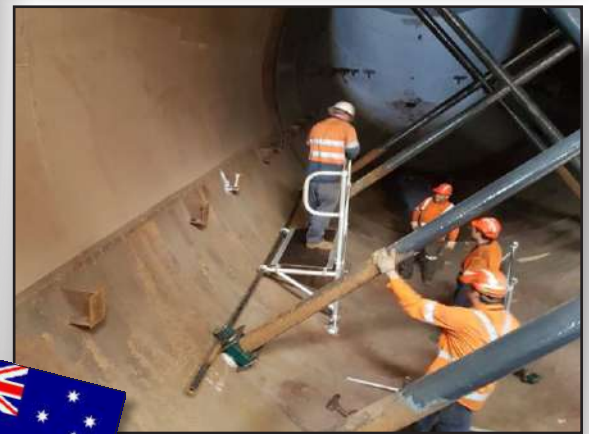
Upon inspection it was discovered that the exhaust duct of this Australian waste gas cleaning plant was suffering from significant corrosion. Originally 8mm thick, accelerated corrosion had resulted in a significant reduction in thickness and several holes throughout the duct.

On an extended maintenance shutdown of the plant, highly compromised sections of the horizontal duct were cut out and replaced with newly fabricated plates along with replacing the top vertical sections. CeramAlloy HTL had been successfully used to protect sections of the plant in previous years so it was chosen to protect not only the newly

fabricated areas but also the rest of the duct totaling an area of over 10,000 sq ft.

To prepare the surface an initial abrasive blast to the existing sections of the duct with coarse garnet was used to remove the residue and corrosion, followed by a second pass with angular steel grit. This was done in order to completely remove any contaminants and produce a clean, profiled surface. Immediately upon completion of abrasive blasting the first layer of CeramAlloy HTL was applied followed by a second.

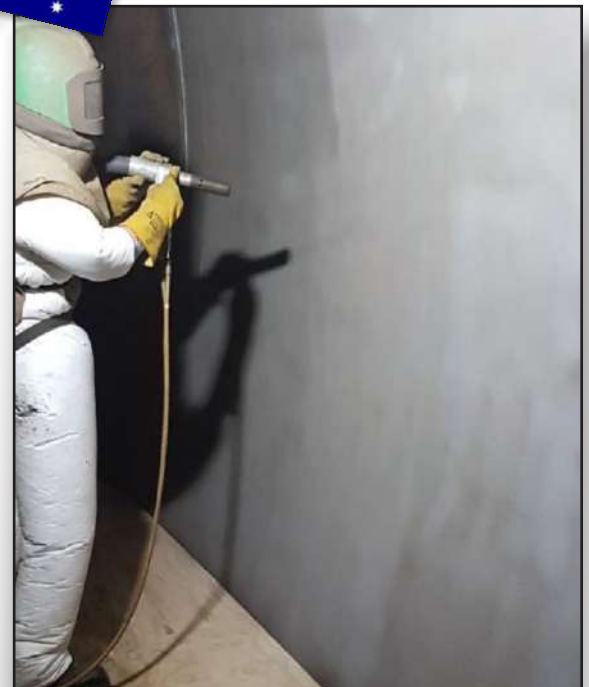
After the coating was complete, the vertical stack was reassembled and lifted into place.
