Aluminum Can Manufacturer Protects Gray Water Tank With CeramAlloy

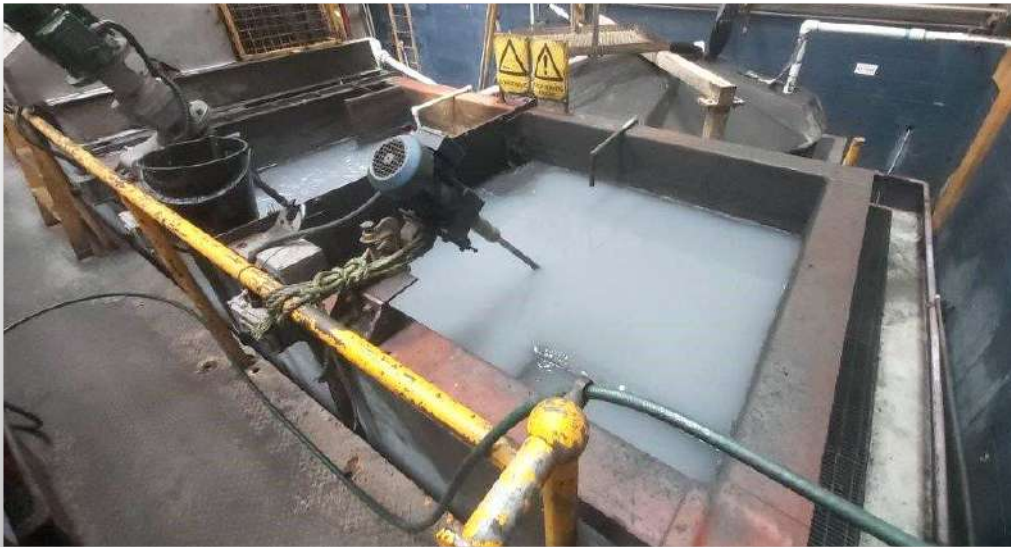
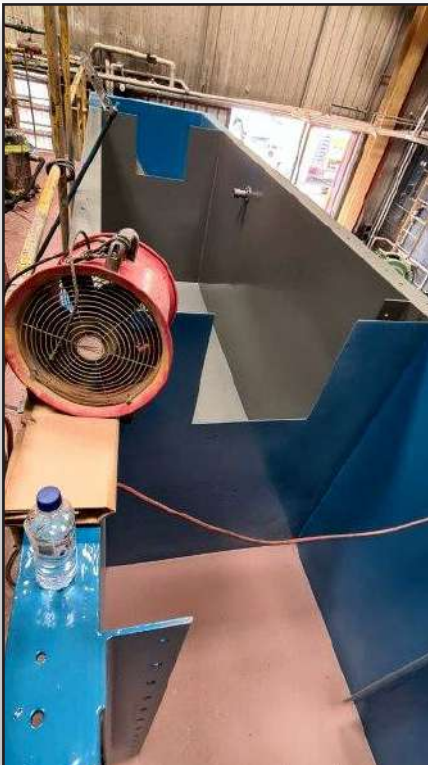
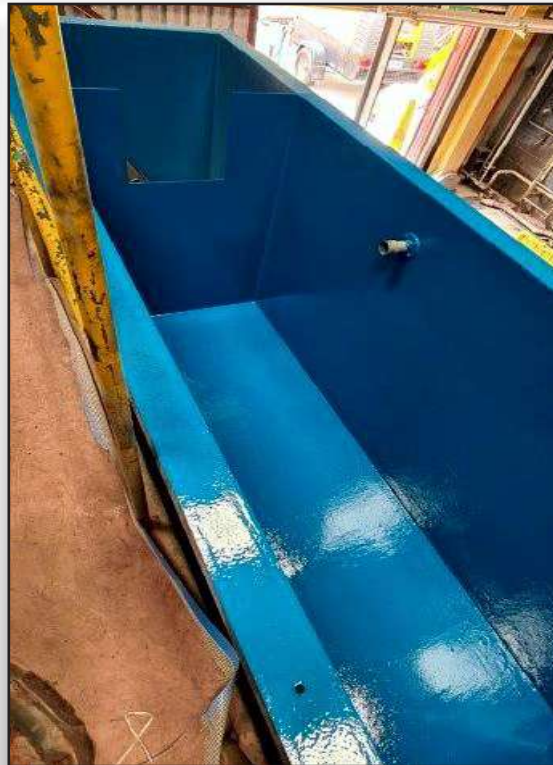
In this steel tank, 98% sulphuric acid and sodium hydroxide are mixed with the manufacturing byproduct gray water to neutralize the content of the water. The existing rubber liner was corroding and had holes, creating leaks in the tank.

The rubber liner was high pressure water blasted off the inner tank surface. The inner surface was then abrasive blasted followed by a thorough cleaning. Two coats of CeramAlloy CL+AC were applied to provide corrosion protection. Not only did this application save this manufacturer the cost of a new tank, the downtime was limited to only 5 days.
