School District Solves Safety and Unsightly Wall Issues

A northeastern school district needed to upgrade their facilities' hallways and restrooms. The original wall surfaces were ceramic tiles that had become cracked with missing tiles in many locations. This condition was a serious safety concern for the district officials.

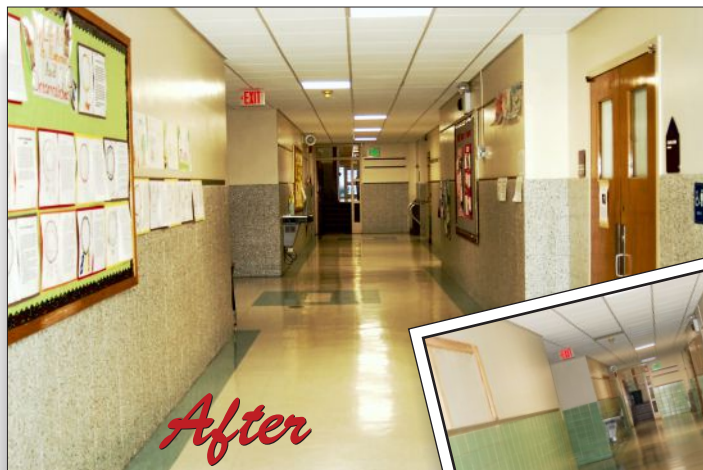
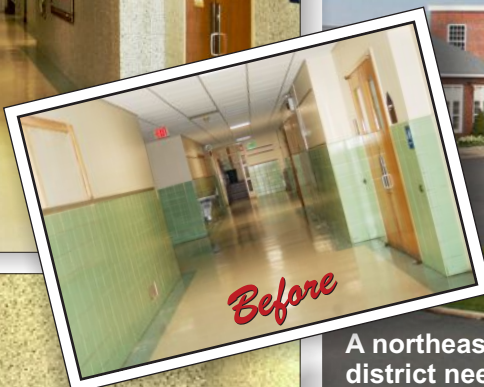
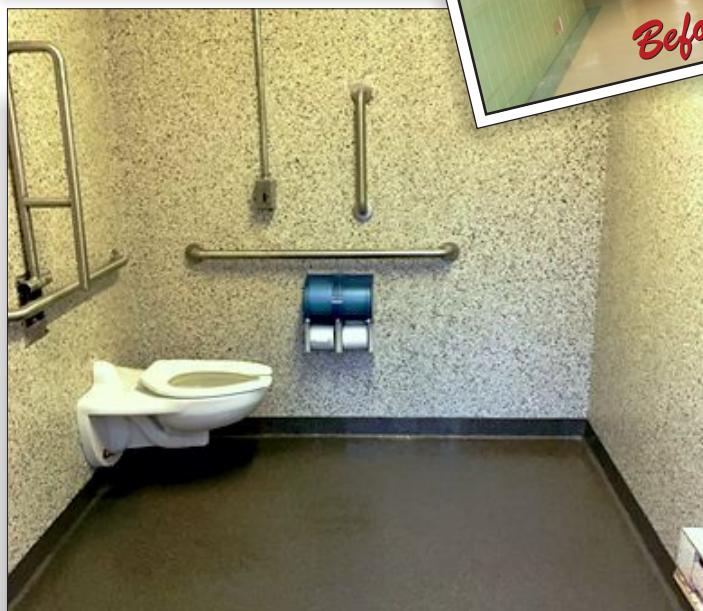
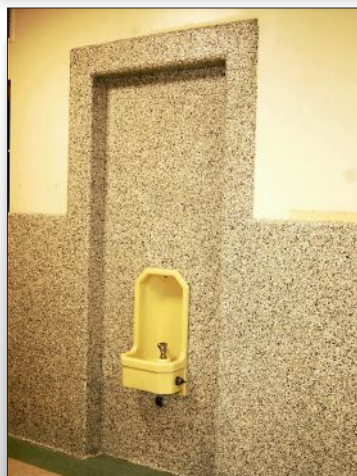
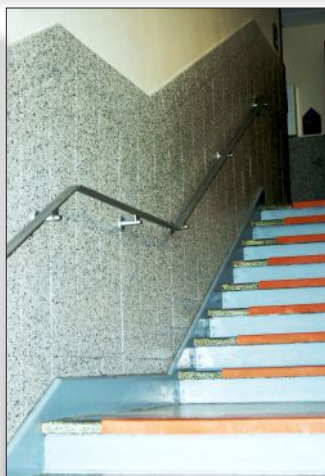
Following the appropriate surface preparation, which included abrading and cleaning the tiles, the walls were treated with a 4-coat ENECRETE DuraFill system. This system included rolling/brushing

a layer of DuraFill and then manually broadcasting colored decorative vinyl chips/flakes into the wet DuraFill and letting this first layer set overnight. After it has dried a trowel is used to smooth out and remove any loose chips/flakes.

Additional similar layers – a total of 3 – were applied each day followed by a final layer of just the DuraFill clear resins – about one week total.

This DuraFill broadcast system application also included filling in any damaged and missing tiles with ENECRETE DuraQuartz.
