**Client:** Pennsylvania Power Plant

## ENESEAL Solves Corrosion Problems on Critical Electrical Switchgear Cabinets in Western PA

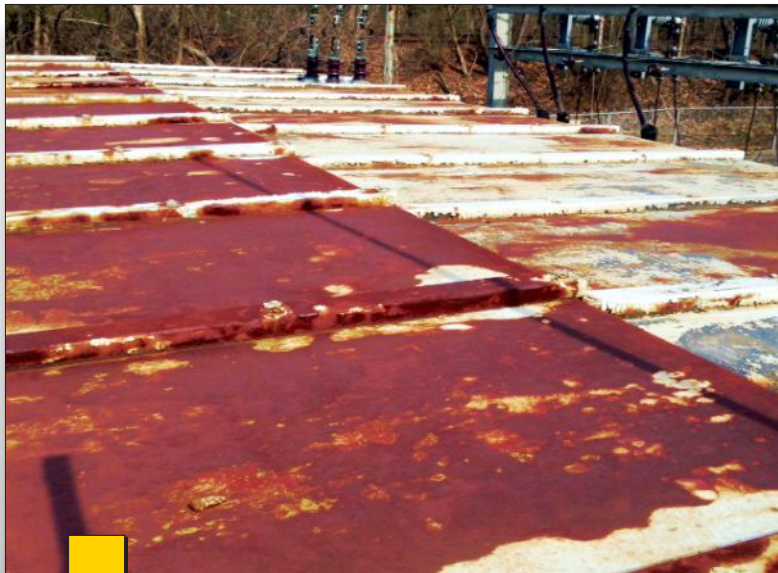
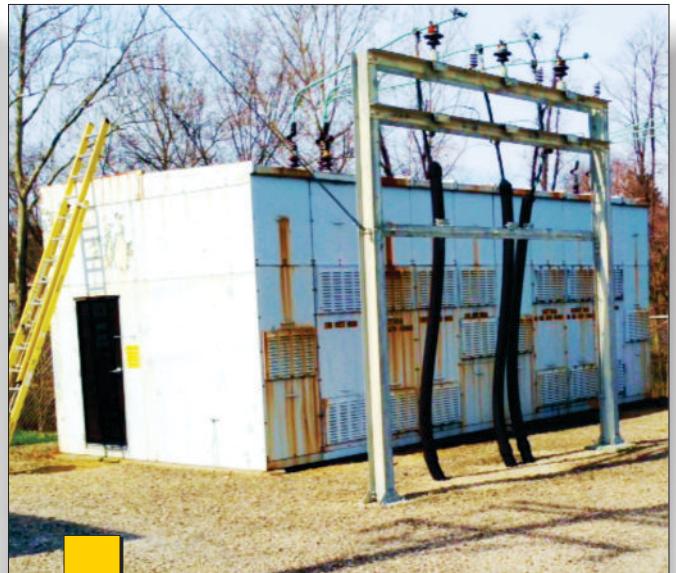
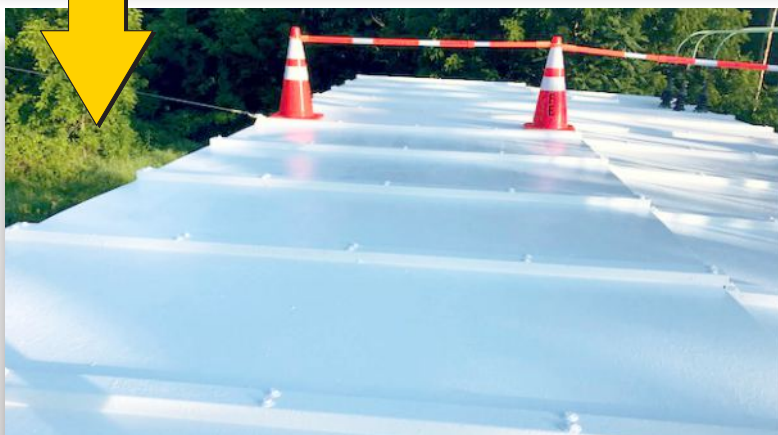
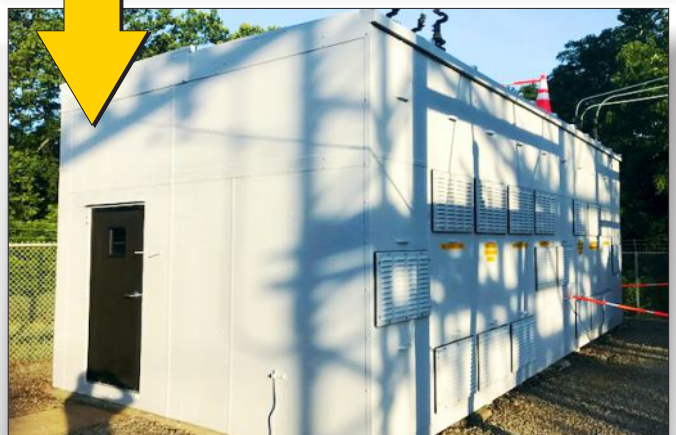
**Problem:** This badly corroded 30'L x 10'W x 12'H switchgear cabinet was vulnerable to leaks due to severe corrosion. Any water that leaked into the cabinet would possibly destroy critical electrical equipment inside.

**Solution:** The surface of the roof was ground and cleaned. A rust convertor was then applied and the roof's end caps were replaced. Two coats of ENESEAL CR were applied for corrosion protection. One coat of ENESEAL HR, to provide heat refraction properties, was applied to keep the equipment inside cool.

The exterior walls were also ground then wiped down with denatured alcohol, followed by three coats of ENESEAL CR.
