FLEXICLAD Repairs Cavitated Pump in Puerto Rico

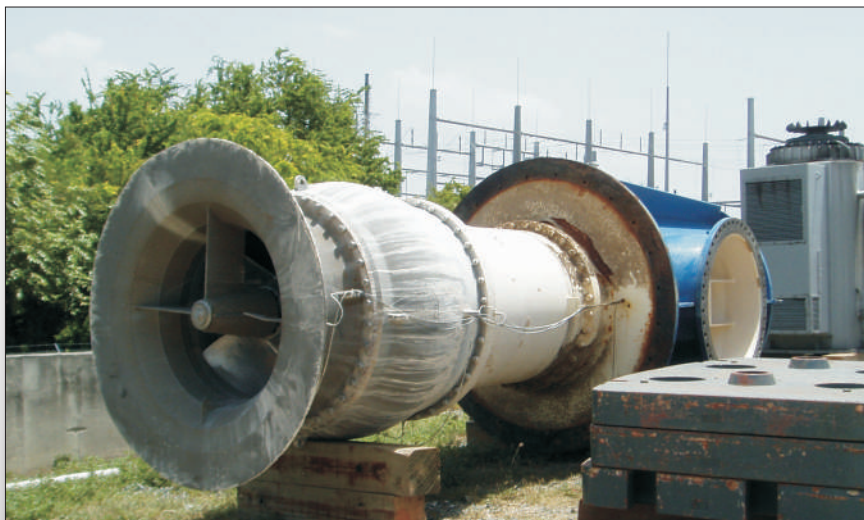
The stainless steel impeller of this large pump, located at a waste water treatment facility in Puerto Rico, was suffering from severe cavitation. The facility engineers needed a fast, reliable as well as cost-effective repair. The local ENECON Distributor was contacted to help find a solution.

The impeller was then protected from future cavitation damage with **DuraTough DL**.

In addition, **CeramAlloy CL+AC** was also used to protect the impeller's edges. **CeramAlloy CP+AC** and **CL+AC** were also used to rebuild and protect the pump casing which had significant corrosion damage.

It was decided that the impeller would first be prepared by grit blasting, followed by all cavitated areas being rebuilt with **DuraTough DP**.
