Repair & Protection Of Split Case Pump With CeramAlloy & CHEMCLAD

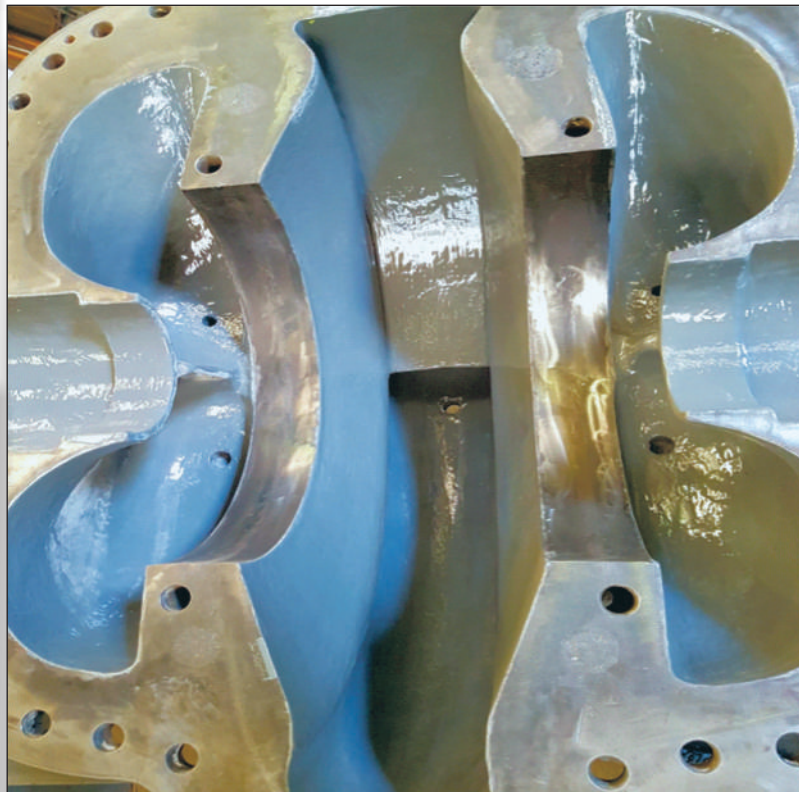
After the curing process was complete, the protected area was first tested for thickness then spark tested at 3,000 volts. The minimum thickness of 600 microns was easily achieved.
