German Utility Company Repairs and Protects Cavitation Damage on Francis Turbine with CeramAlloy[®] & DuraTough[®]

Client: German Hydroelectric Plant.

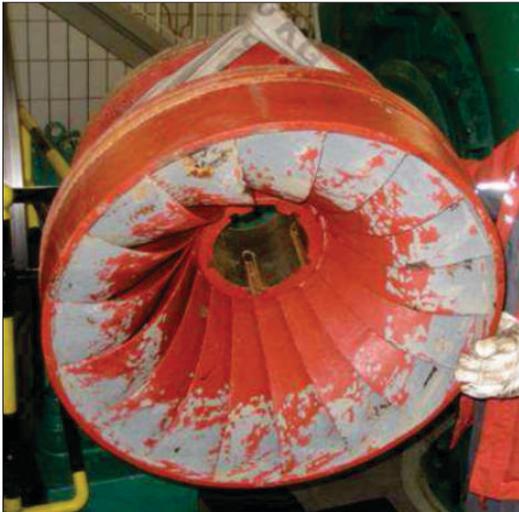
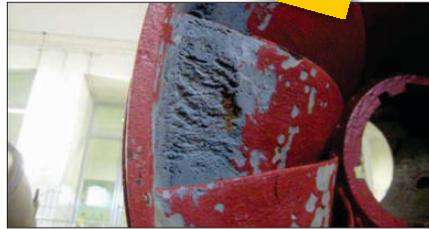
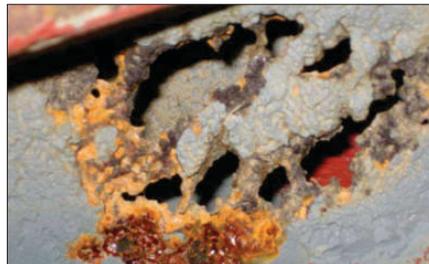
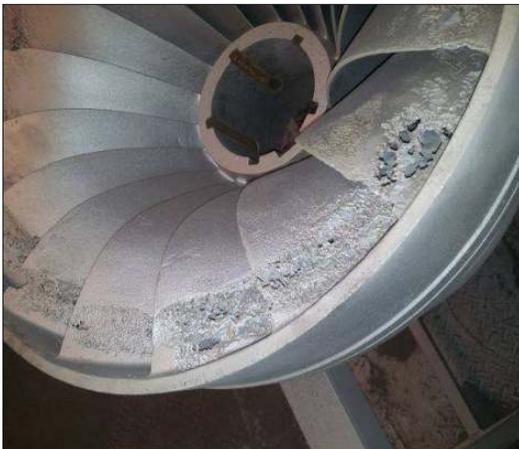
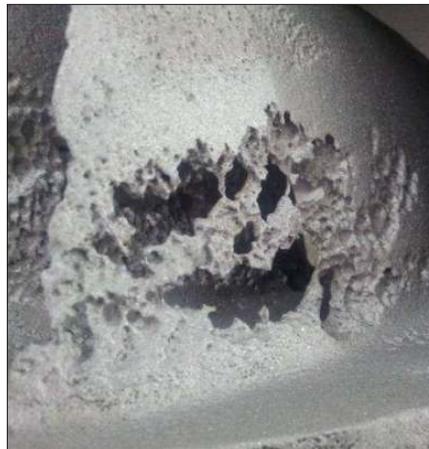
Problem: Francis turbine vanes were suffering from erosion and corrosion due to the effects of cavitation after the failure of a previously applied coating.

Solution: After grit blasting the turbine, the vanes were rebuilt by tack welding steel mesh to the deeply cavitated areas. The vanes were then rebuilt with CeramAlloy CP+AC then two coats of CeramAlloy CL+AC were applied. DuraTough DL was applied to protect against future cavitation problems.

- 1. Steel mesh is welded to the vanes.**
- 2. CeramAlloy CP+AC covers the mesh repairs.**
- 3. CeramAlloy CP+AC rebuilds the vanes.**
- 4. The turbine is coated with CeramAlloy CL+AC.**
- 5. DuraTough DL provides the cavitation protection.**
