Severely Cavitated Turbine Shaft Repaired Using METALCLAD & DuraTough

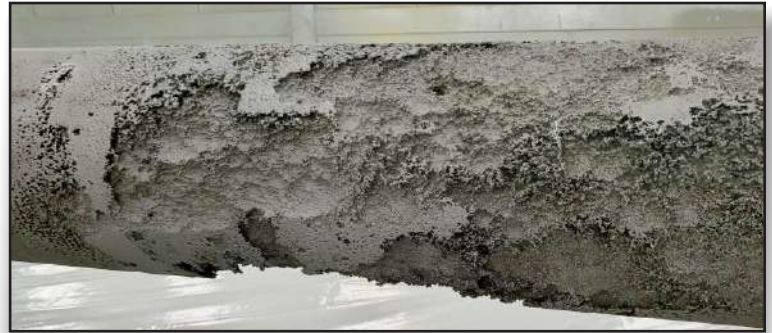
A turbine shaft at a utility in the midwestern U.S. was badly damaged by cavitation. The ENECON specialists in the area recommended a repair using both **METALCLAD DurAlloy** and **FLEXICLAD DuraTough**.

First the shaft was grit blasted, cleaned and repaired with **DurAlloy** to build up the diameter back to original size. The entire shaft was then brush blasted and coated with **DuraTough DL** to prevent future cavitation damage.
