## Office Building Drain Pipe Repaired With DurAlloy & Protected With CeramAlloy

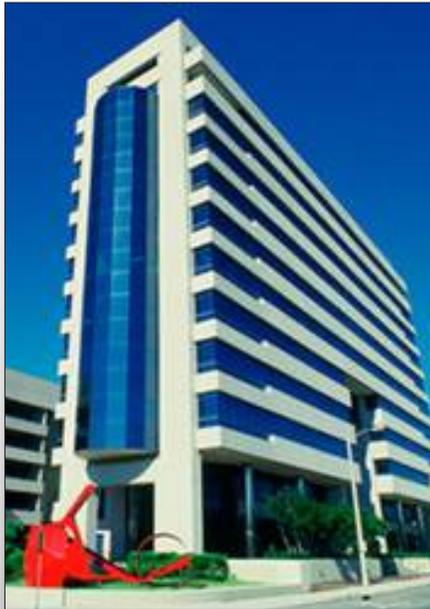
This eight inch diameter drain pipe was located thirty six feet in the air, behind a drop ceiling, in an office building lobby in southern Florida. The building's maintenance team found a three foot long crack in the pipe that was leaking.

Initially, the building's maintenance team used an aerosol spray-on flexible "rubber" repair material which quickly failed. A reliable, proven solution was needed fast. The ENECON Field Engineering Specialist was contacted and a new, trusted solutions was agreed to.

The flexible repair material and rust had to be removed from the pipe. The pipe was

mechanically ground to the appropriate profile. Then the crack was cleaned by using a small wire brush. The pipe was cleaned with denatured alcohol.

METALCLAD DurAlloy was used to repair the cracked pipe surface. Additional DurAlloy was then applied to the entire pipe followed by overlapping layers of reinforcing mesh to provide structural stability to the pipe. A third layer of DurAlloy was applied on top of the mesh.

Finally, METALCLAD CeramAlloy CL+AC gray was applied to the entire pipe to provide ultimate corrosion protection.
