## Pump Impeller Still Performing After 10 Years

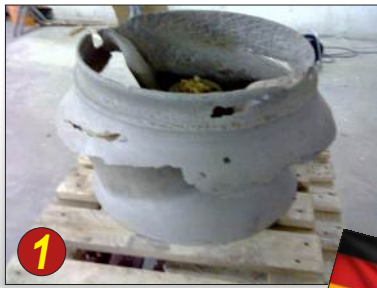
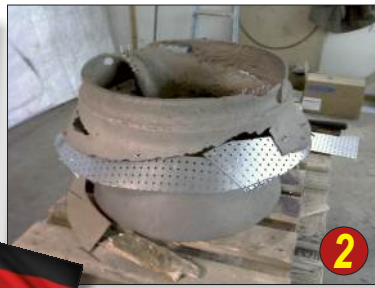
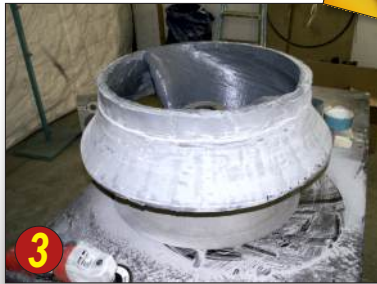
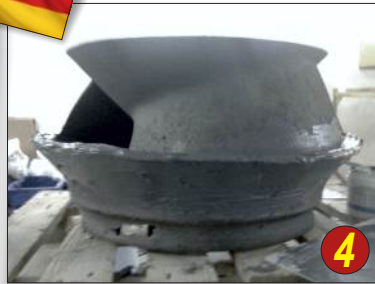
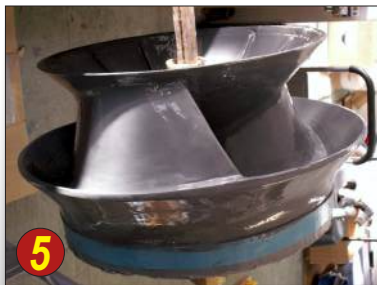
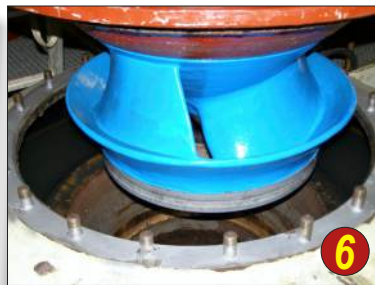
In 2009 this wastewater treatment plant channel pump impeller was headed for the scrap pile. ENECON Germany was contacted to provide a possible reclamation solution.

The wastewater treatment plant's engineers were skeptical of this repair because the pump operated at 980 rpm.

The impeller was inspected soon after the repair was made. After short intervals of operation no defects were detected.

After 10 years in service, the pump was dismantled during a shutdown. The impeller was inspected and only minor touch-up spot repairs were necessary.

After abrasive blasting the impeller veins were repaired with sheets of metal welded in place. CeramAlloy CP+AC was then used to rebuild the shape and contour of the impeller.

A hand grinder was used to smooth the impeller's surface. Two coats of CeramAlloy CL+AC were then applied to provide the erosion / corrosion resistance necessary in

the wastewater environment.
