Romanian Wastewater Treatment Facility Repairs Impeller Shaft with DurAlloy

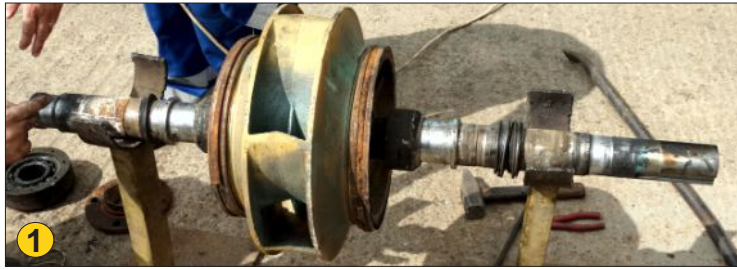
1. Impeller shaft in bad condition after years in service needs to be repaired.

2. Corrosion and wear to the shaft rendered it unusable.
