Cooling Tower Pipes Are Salvaged With METALCLAD & ENESEAL

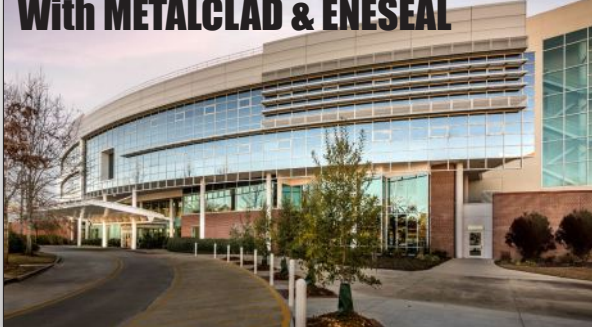
These cooling tower pipes at one of the largest hospitals in northern Louisiana were in a very corroded state. The hospital was considering replacing these pipes at an estimated cost of \$85,000, with considerable downtime. The downtime was the most troublesome issue for the hospital; they needed a solution that would allow them to keep the units operating.

Over the last few years, the hospital had continually painted the pipes, encapsulating the rusting areas unknowingly giving the rust a 'safe' place to live and thrive. After inspection, several sections of the pipes had considerable metal loss and there were also active leaks.

First, SpeedAlloy QS was used to stop all of the active leaks. After all the leaks were sealed, DurAlloy

was then used to repair the areas with major metal loss. DuraWrap Carbon Fiber Pipe Wrap was used to reinforce the areas where the leaks were sealed and the metal loss repaired.

Finally, two coats of ENESEAL CR were applied to all of the pipes, as well as their structural legs and concrete bases, to provide corrosion resistance. All of this work was performed with absolutely no interruption the hospitals operations.
