Water Main Pipe At Australian Steel Mill Repaired With DuraWrap

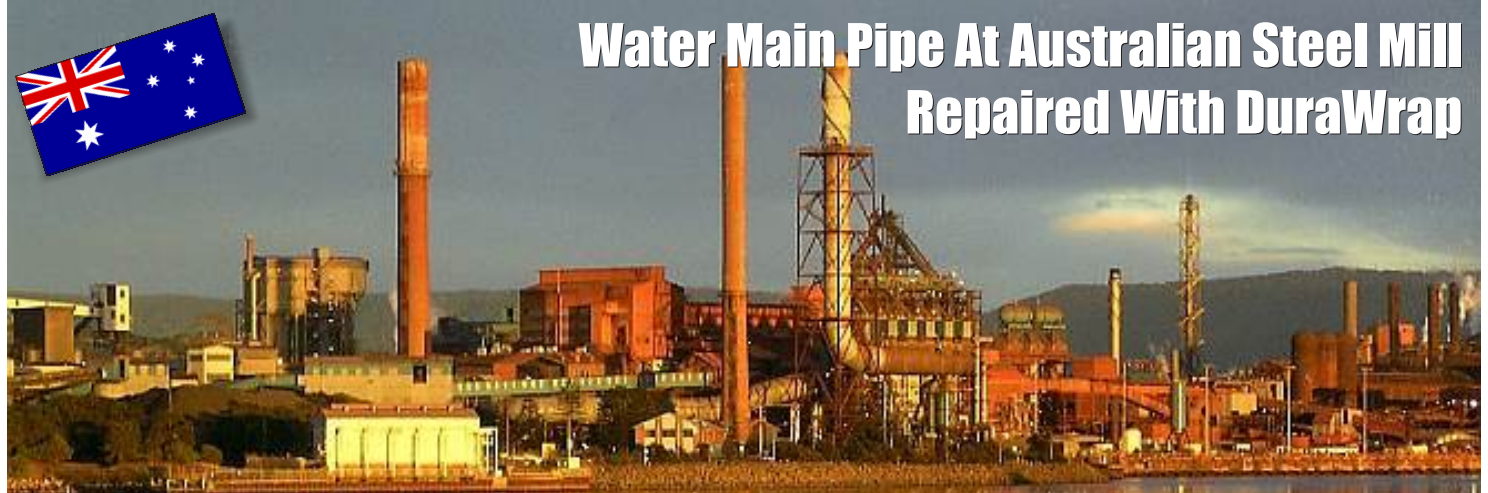
This water main pipe located at an Australian steel mill was constantly exposed to hypochlorite fall out from a nearby cooling tower as well as being in contact with sludge from the mill's process.

Even though the pipe was previously repaired with a 'tape-like' product, the pipe was showing signs of advanced corrosion in this aggressive chemical environment.

The proposed repair method required abrasive blasting to remove all traces of the old, failed protective wrap and the corrosion.

CeramAlloy CP+AC was first used to repair the heavily corroded areas of the pipe. This was followed by an application of the *DuraWrap Carbon Fiber Pipe Wrap System*, because of its extraordinary physical properties.

After full cure was achieved, the pipe was then protected with a custom colored *CHEMCLAD GP* to protect the pipe from exposure in this harsh environment.
