Main Paper Feed Stock Pump Repaired & Resurfaced With CeramAlloy & CHEMCLAD

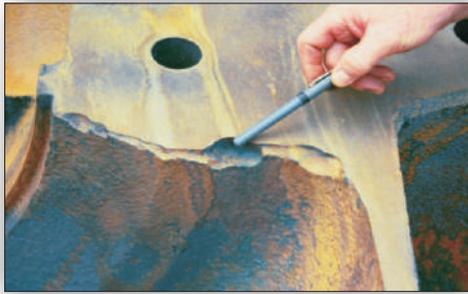
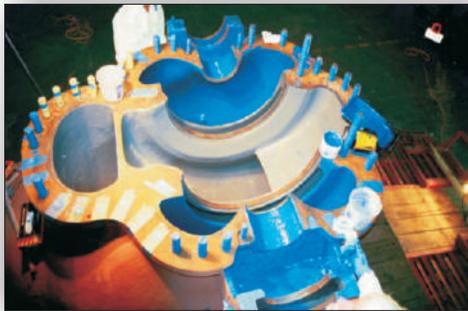
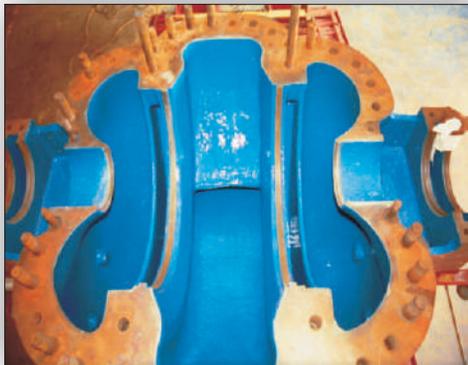
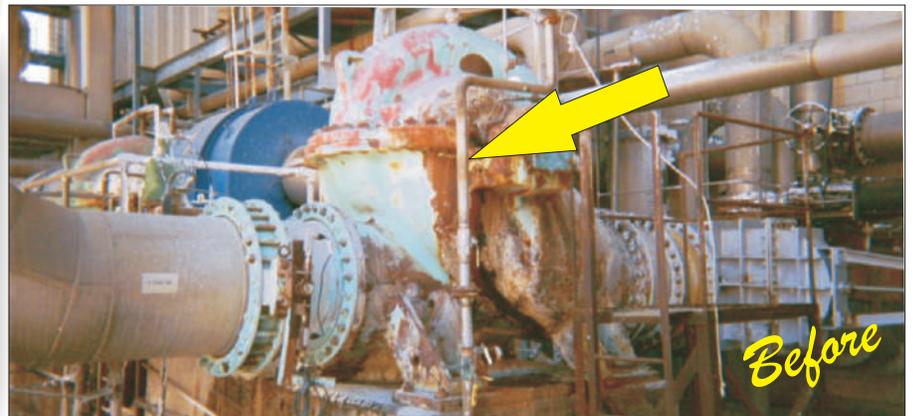
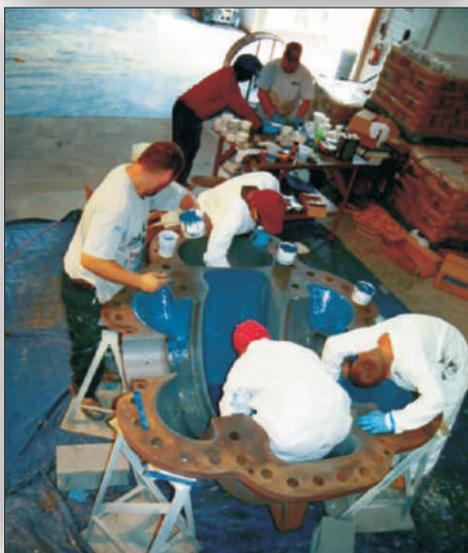
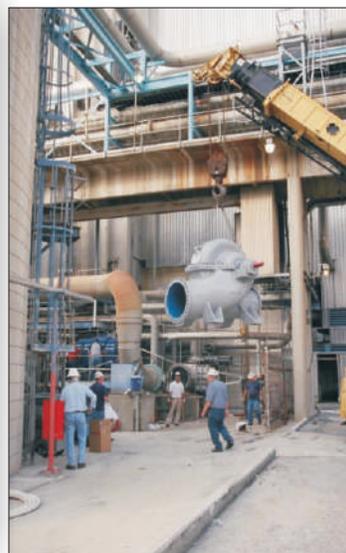
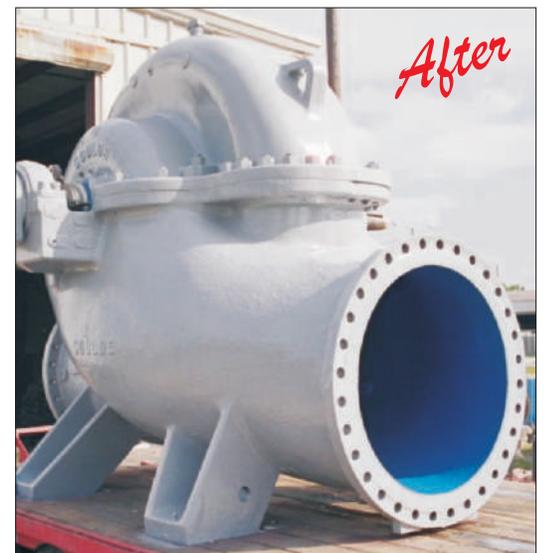
The plant engineers at this large paper mill located in North Carolina needed a cost effective and commercially proven repair solution for their 30-year old main paper feed stock pump which was severely eroded and corroded.

They suggested that all internal surfaces be repaired and resurfaced with CeramAlloy CP+AC and CL+AC. They then recommended that two coats of CHEMCLAD GP be used to protect all external surfaces from the aggressive paper mill environment.
